**REPORT OF PAVEMENT INVESTIGATION  
BAY CITY STATE PARK PAVEMENTS  
BANGOR CHARTER TOWNSHIP, MICHIGAN**

December 2022  
MTC Project No. 221591

Reference: Report of Pavement Investigation  
Bay City State Park Pavements  
Bangor Charter Township, Michigan

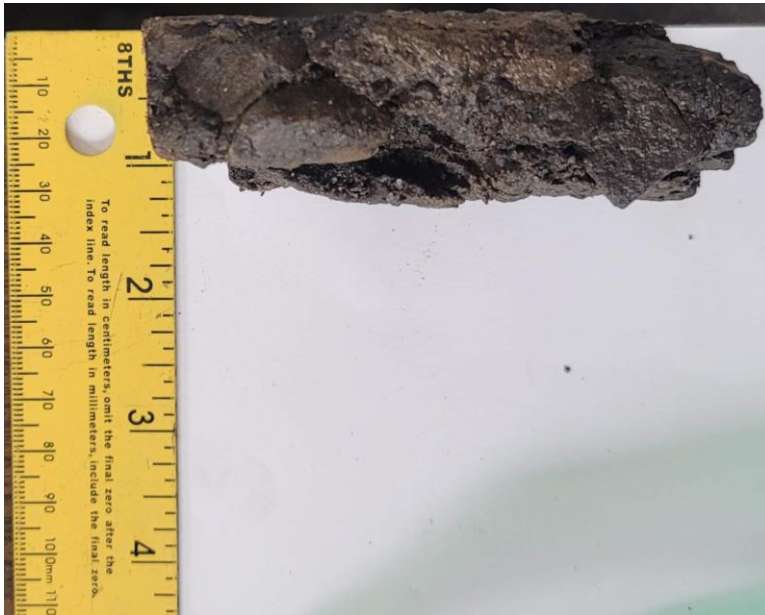
BORING C-1

| Boring | HMA Thickness (in) | Gravel Base Thickness (in) |
|---|---|---|
| C-1 | 1 | 6* |

- Boring C-1 – Possible organic sand seams from 1.4. to 1.5 ft depth (els 583.4 to 583.5 ft)
- Boring C-2 – Possible buried topsoil from 1.4. to 1.7 ft depth (els 583.6 to 583.9 ft)
- Boring C-6 – Possible buried topsoil from 2.7. to 4.0 ft depth (els 582.4 to 583.7 ft)
- Boring C-7 – Fibrous peat (PT) at depths ranging from 3.8 to 4.5 ft (els 580.4 to 581.1 ft)
- Boring C-11 – Black poorly graded sand with silt (SP-SM) with fibrous peat and root fragments at depths ranging from 2.3 to 3.5 ft (els 581.7 to 582.9 ft)
- Boring C-12 – Dark gray poorly graded sand with silt (SP-SM) with fibrous peat and root fragments at depths ranging from 1.7 to 2.3 ft (els 582.7 to 583.3 ft)

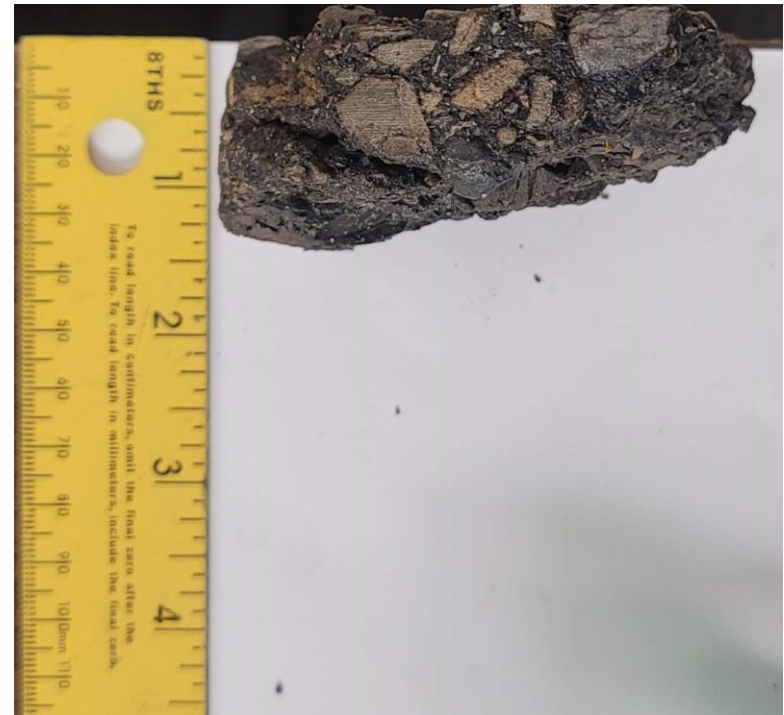
BORING C-2

| Boring | HMA Thickness (in) | Gravel Base Thickness (in) |
|---|---|---|
| C-2 | 1 | 6* |

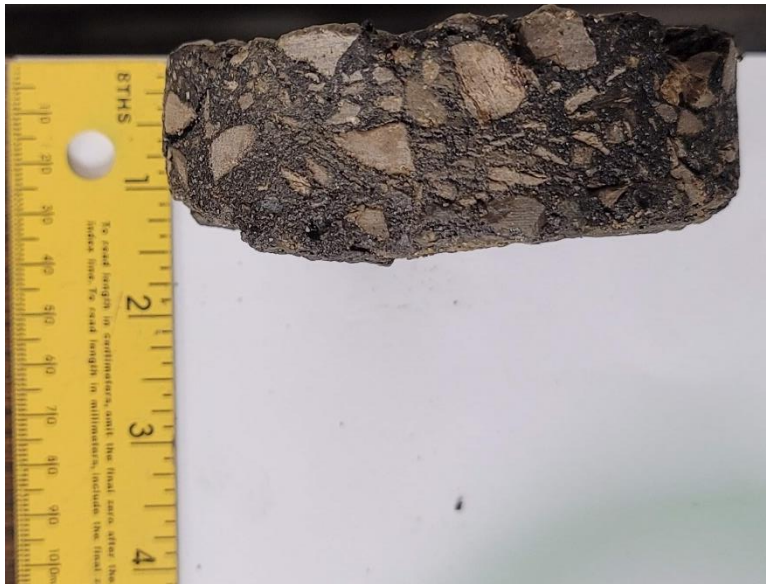
BORING C-3

| Boring | HMA Thickness (in) | Gravel Base Thickness (in) |
|---|---|---|
| C-3 | 1.25 | 7 3/4 |

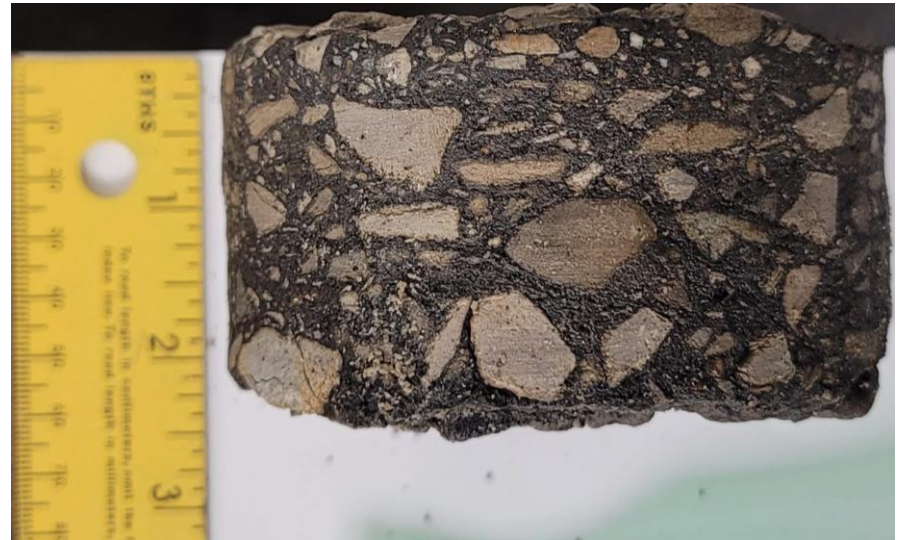
BORING C-4

| Boring | HMA Thickness (in) | Gravel Base Thickness (in) |
|---|---|---|
| C-4 | 2 | 5* |

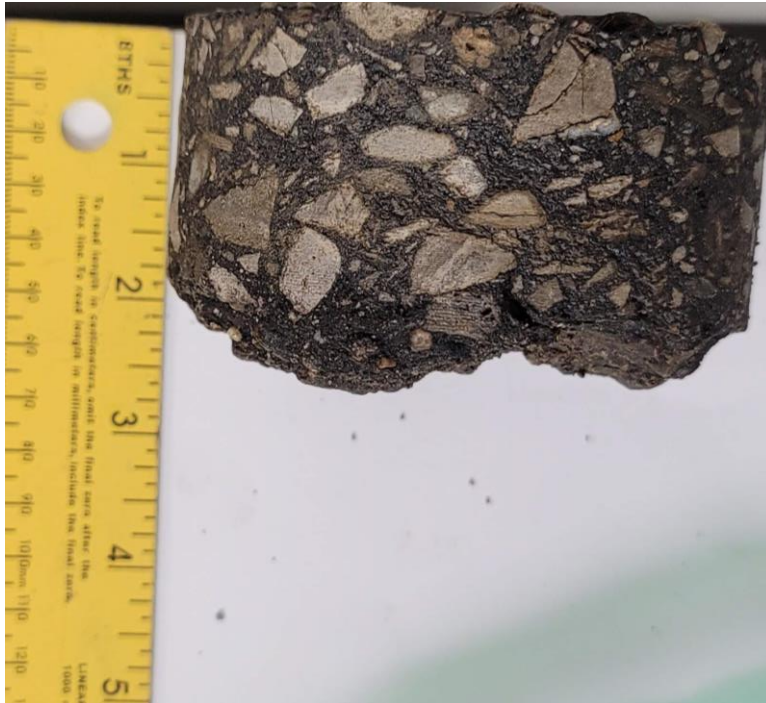
BORING C-5

| Boring | HMA Thickness (in) | Gravel Base Thickness (in) |
|---|---|---|
| C-5 | 2 | 10 |

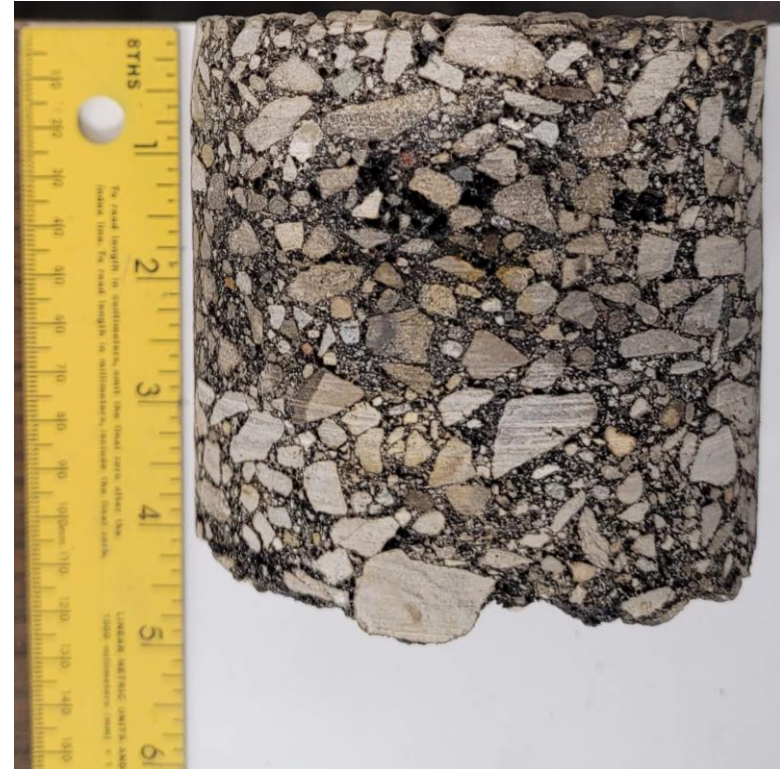
BORING C-6

| Boring | HMA Thickness (in) | Gravel Base Thickness (in) |
|---|---|---|
| C-6 | 3 1/2 | 4 1/2 |

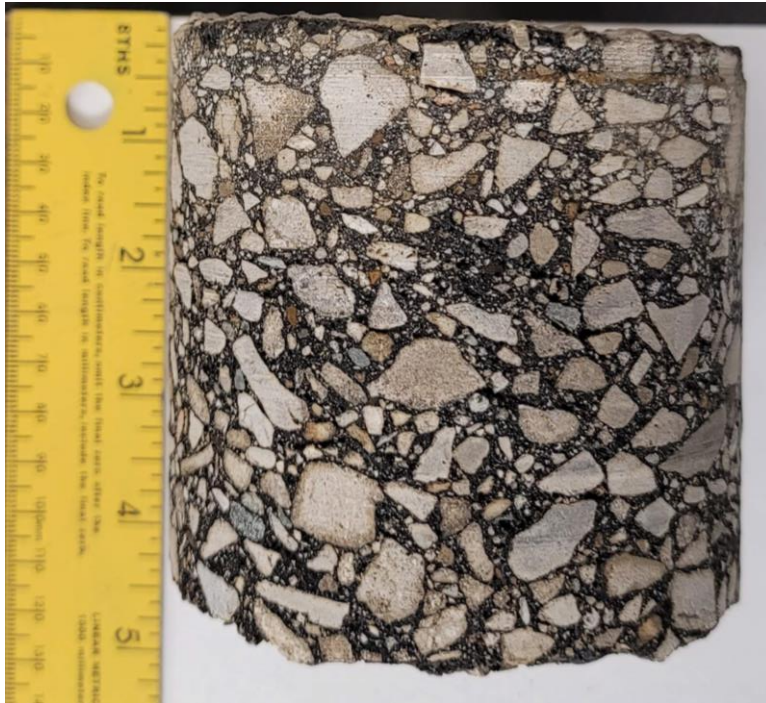
BORING C-7

| Boring | HMA Thickness (in) | Gravel Base Thickness (in) |
|---|---|---|
| C-7 | 3 1/2 | 6 1/2 |

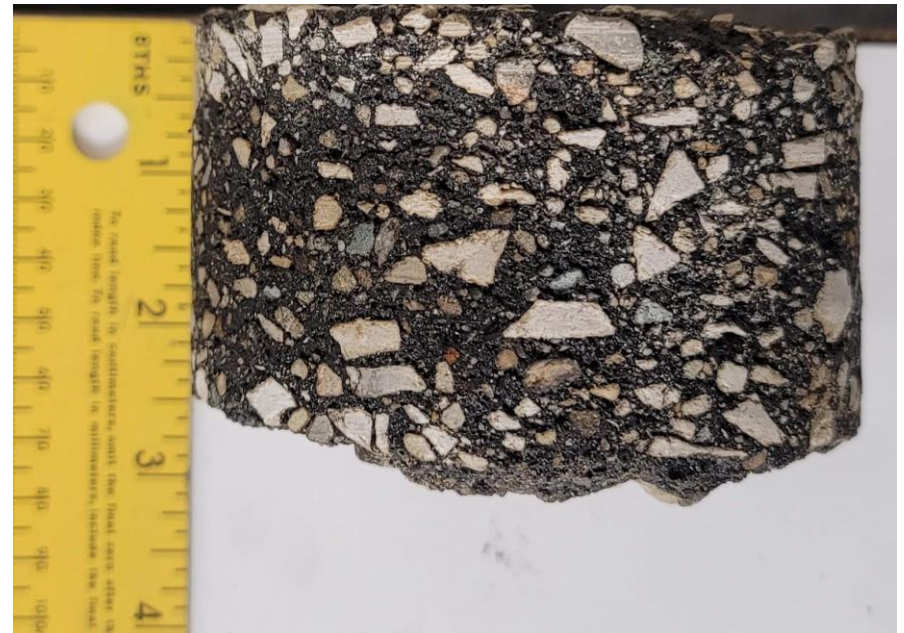
BORING C-8

| Boring | HMA Thickness (in) | Gravel Base Thickness (in) |
|---|---|---|
| C-8 | 2 | 8 |

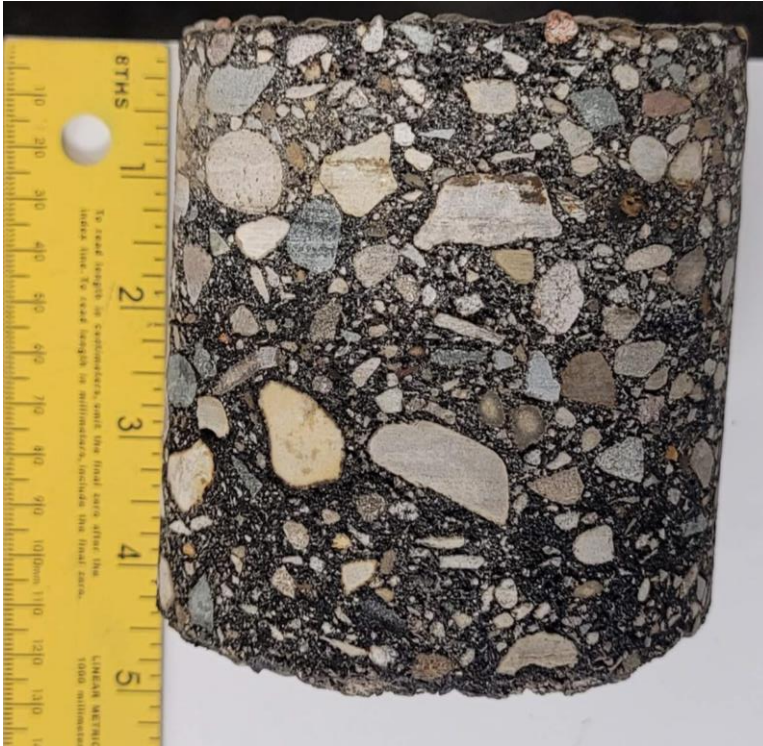
BORING C-9

| Boring | HMA Thickness (in) | Gravel Base Thickness (in) |
|---|---|---|
| C-9 | 4 | 16 |

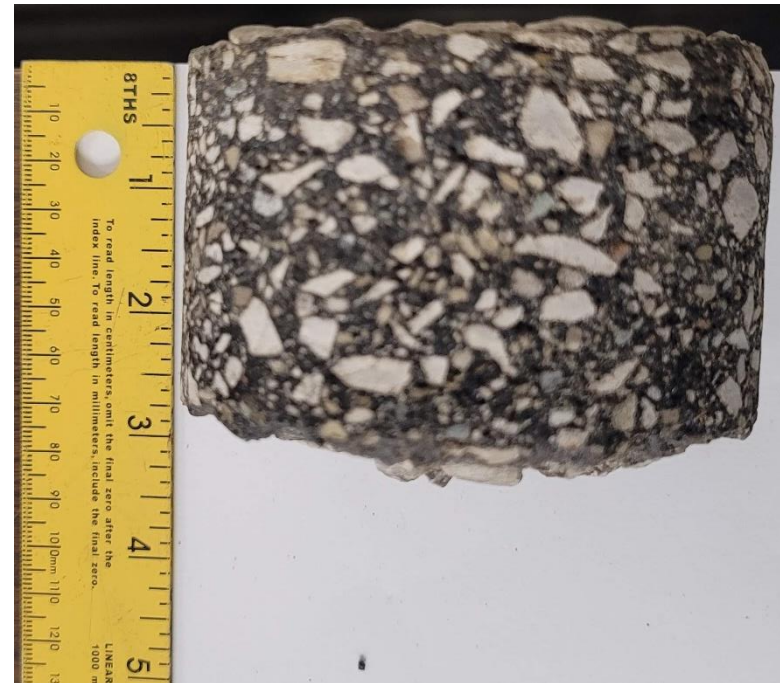
BORING C-10

| Boring | HMA Thickness (in) | Gravel Base Thickness (in) |
|---|---|---|
| C-10 | 2 1/4 | 7 3/4 |

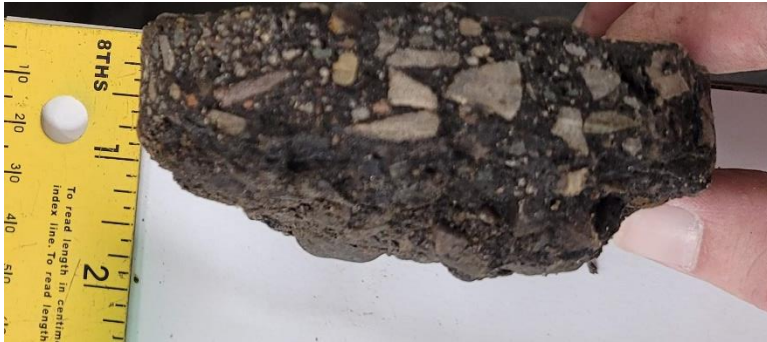
BORING C-11

| Boring | HMA Thickness (in) | Gravel Base Thickness (in) |
|---|---|---|
| C-11 | 1 | 9 |

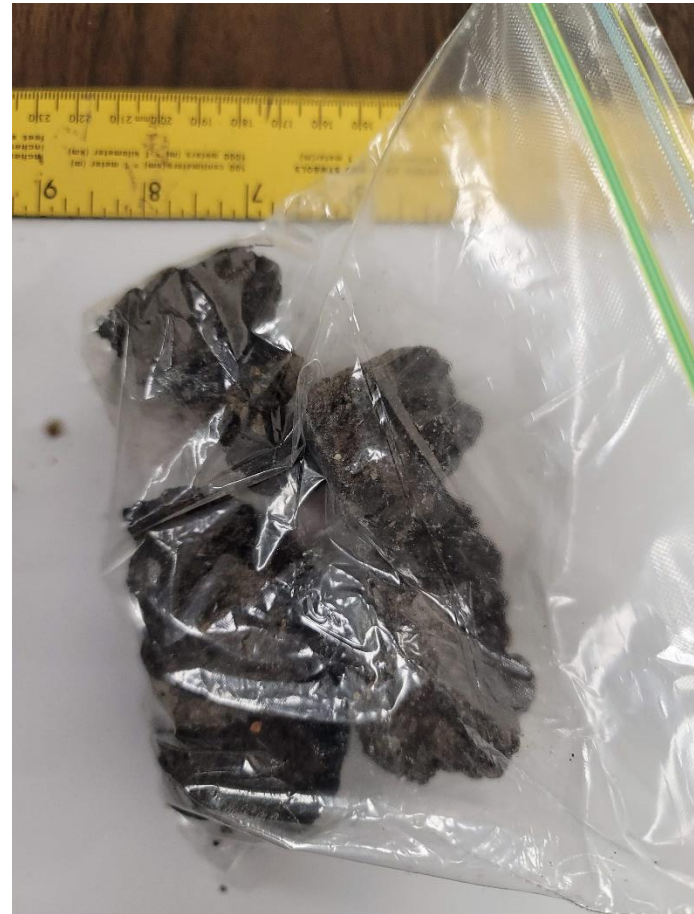
BORING C-12

| Boring | HMA Thickness (in) | Gravel Base Thickness (in) |
|---|---|---|
| C-12 | 1 | 9 |

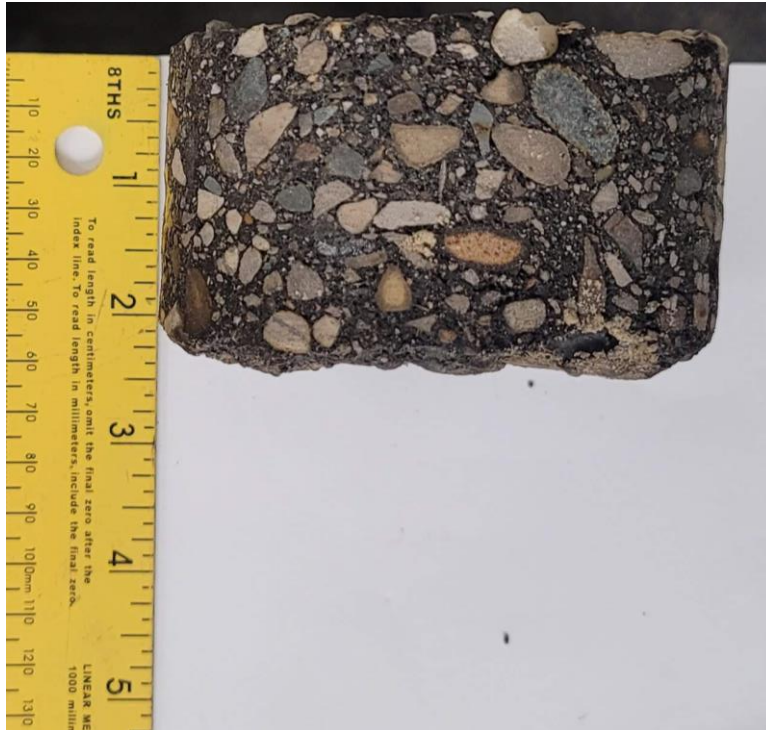
BORING C-13

| Boring | HMA Thickness (in) | Gravel Base Thickness (in) |
|---|---|---|
| C-13 | 2 | 8 |

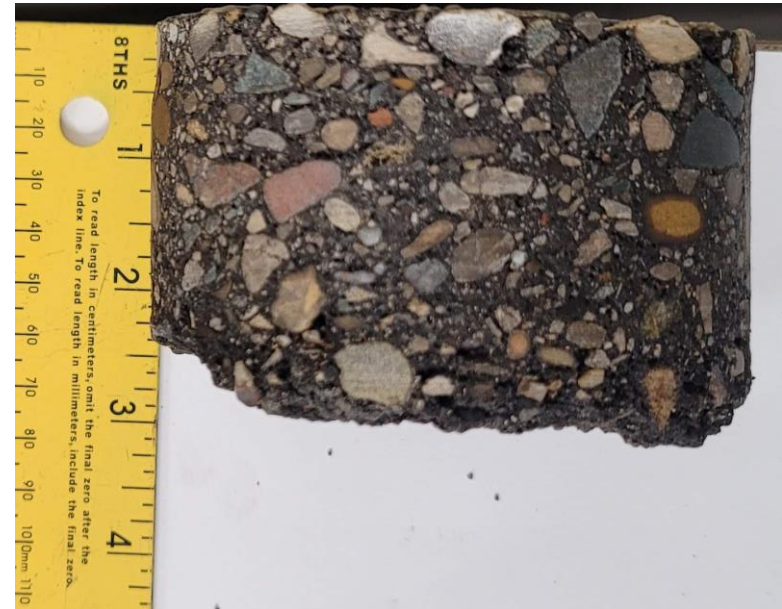
BORING C-14

| Boring | HMA Thickness (in) | Gravel Base Thickness (in) |
|---|---|---|
| C-14 | 2 1/2 | 7 |

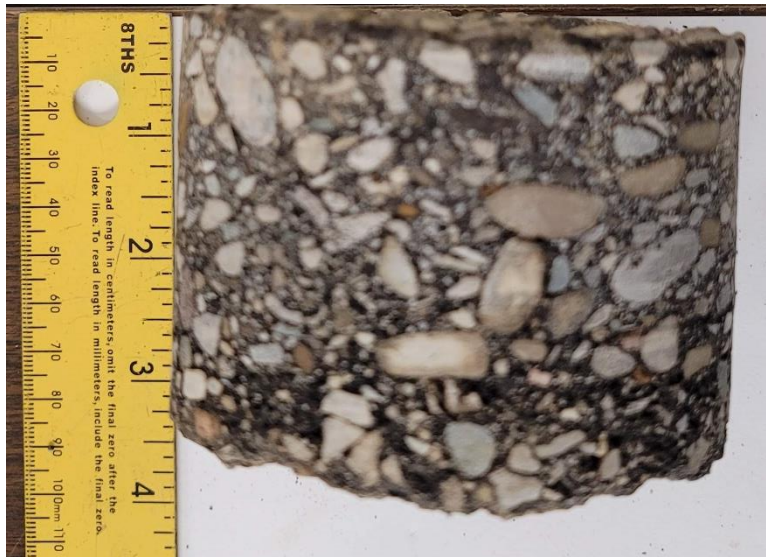
BORING C-15

| Boring | HMA Thickness (in) | Gravel Base Thickness (in) |
|---|---|---|
| C-15 | 2 3/4 | 7 |

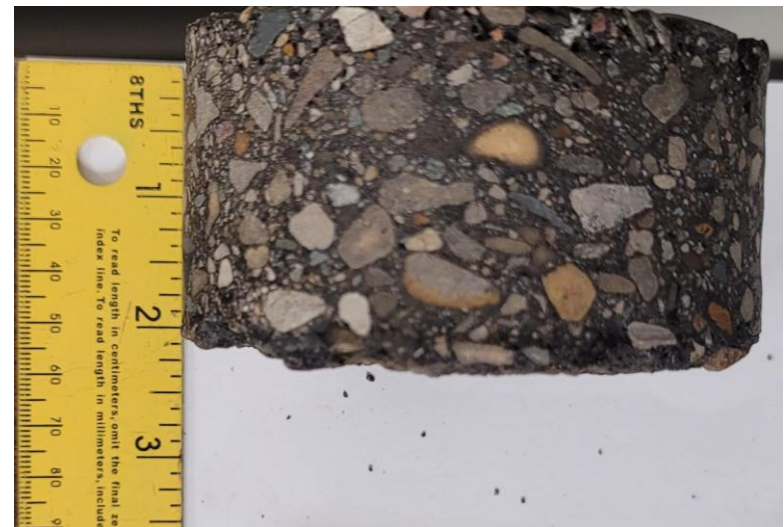
BORING C-16

| Boring | HMA Thickness (in) | Gravel Base Thickness (in) |
|---|---|---|
| C-16 | 2 | 8 |
