**PRE-RENOVATION LIMITED ASBESTOS AND LEAD-CONTAINING PAINT SURVEY
JACKSON ARMORY**

2700 ARGYLE STREET
JACKSON, MI 49202

Project #188BS25298

June 6, 2025

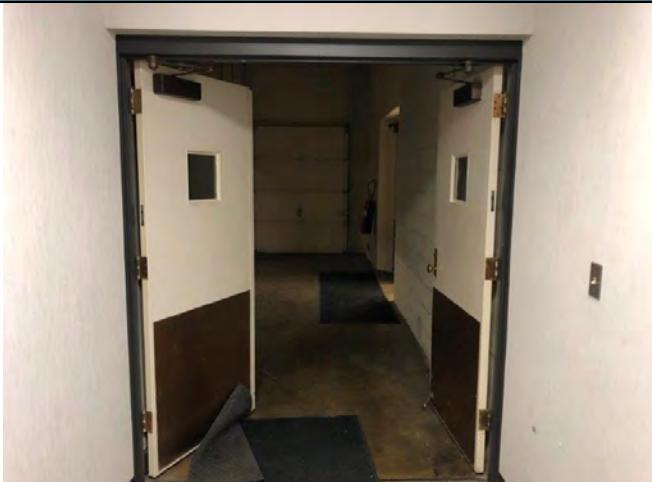
Photograph #1

HA-1: Fire door - Fire door & frame

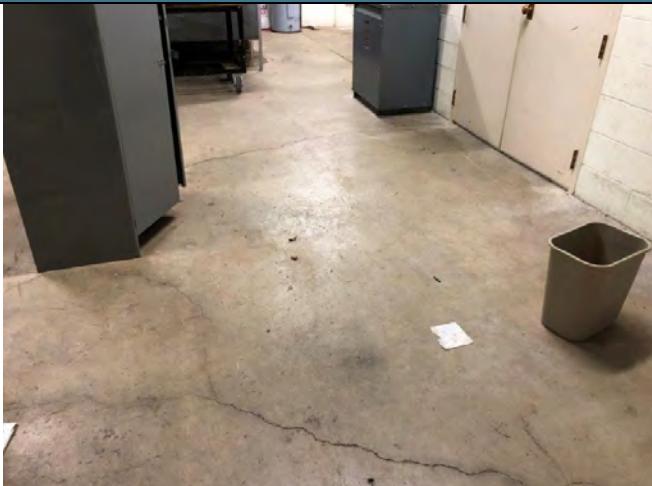
Photograph #2

HA-2: Concrete chip - poured concrete slab foundation, deck

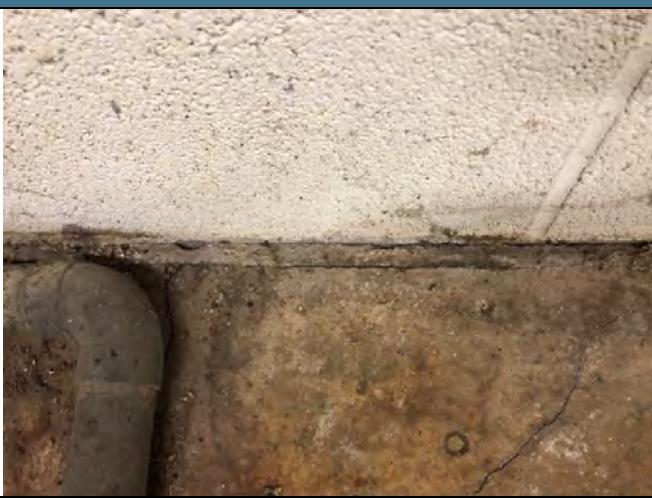
Photograph #3

HA-3: Expansion joint- black, between concrete pad foundation and walls

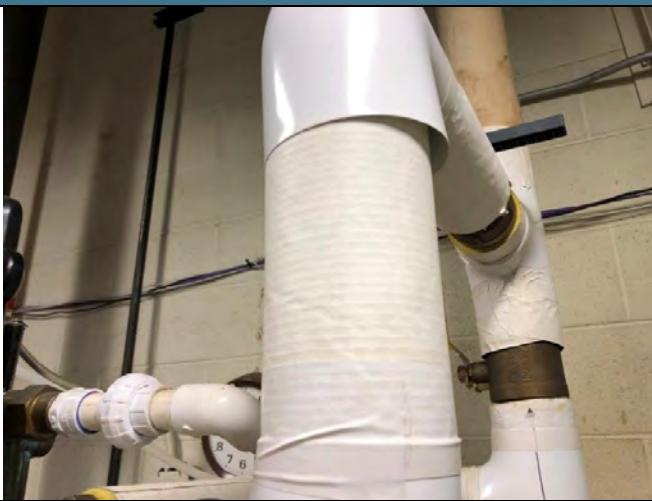
Photograph #4

HA-4: Pipe insulation - white paper with integrated canvas wrapped fiberglass pipe

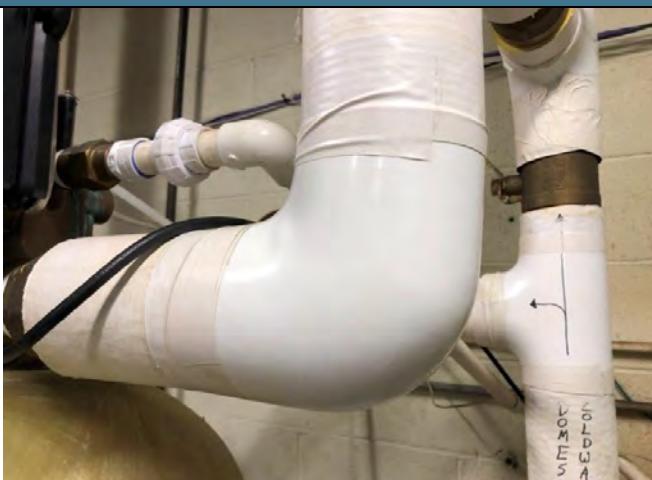
Photograph #5

HA-5: Pipe fitting - plastic wrapped fiberglass fitting

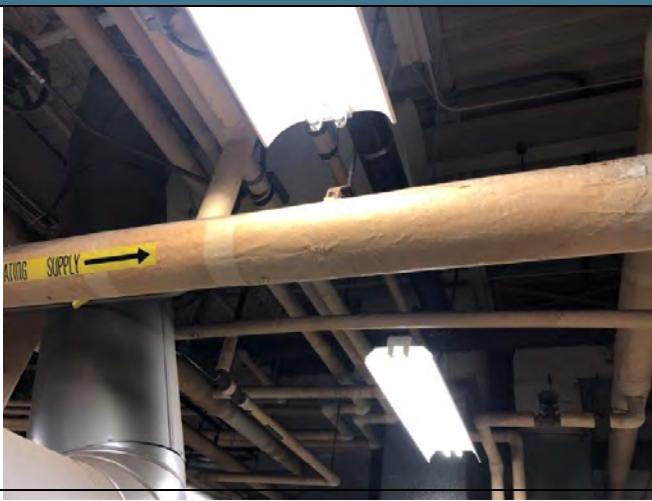
Photograph #6

HA-6: Pipe insulation - paper wrapped fiberglass insulation

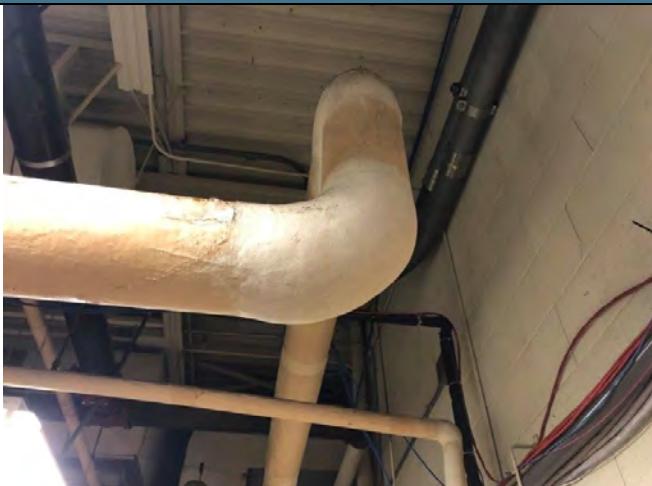
Photograph #7

Homogenous Material Description
HA-7: Pipe fitting - canvas wrapped mudded pipe fitting
Asbestos Present (Yes/No/Assumed)
No
Total Quantity Present
507 Fittings
Additional Notes

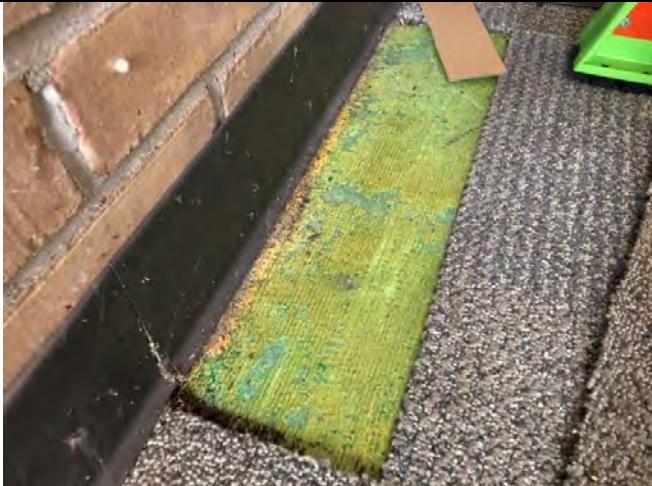
Photograph #8

Homogenous Material Description
HA-8: Carpet mastic - brown/green
Asbestos Present (Yes/No/Assumed)
No
Total Quantity Present
34323 SF
Additional Notes

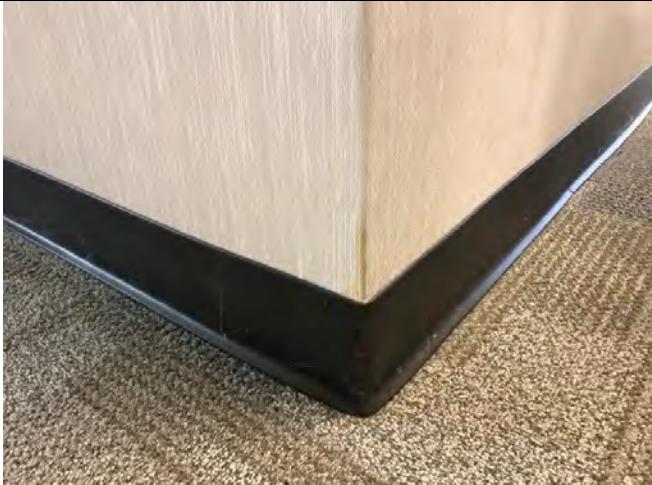
Photograph #9

Homogenous Material Description
HA-9: Cove base - 4" grey with adhesive
Asbestos Present (Yes/No/Assumed)
No
Total Quantity Present
7535 LF
Additional Notes

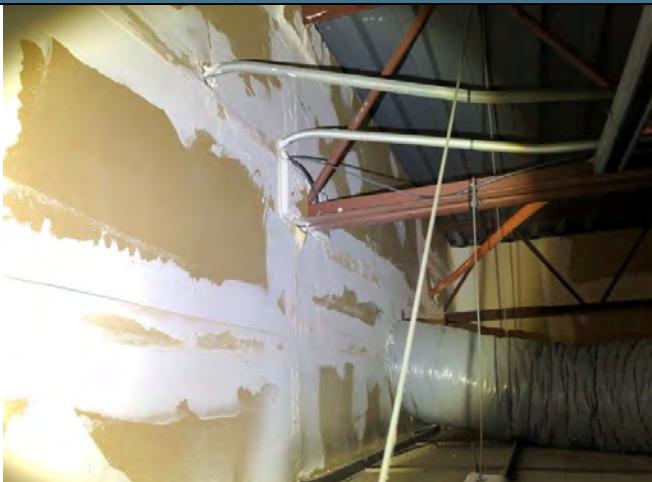
Photograph #10

HA-10: Wallboard system

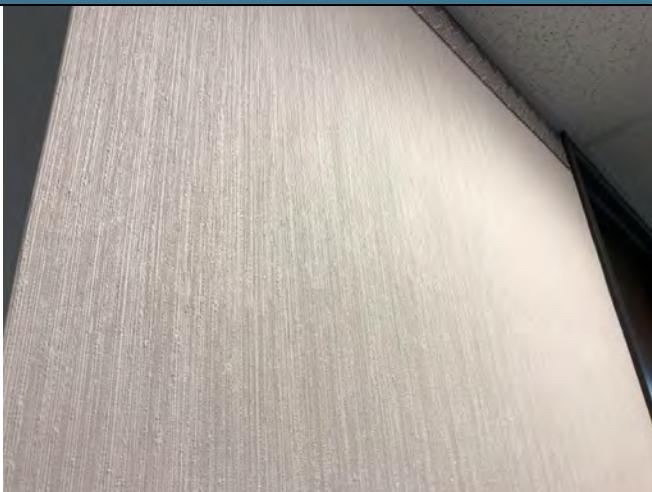
Photograph #11

HA-11: Wallpaper - canvas with vertical line texture

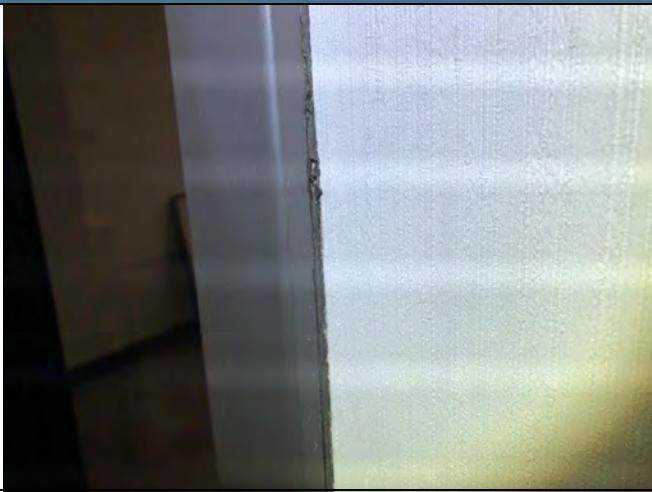
Photograph #12

HA-12: Interior caulk - brown, soft

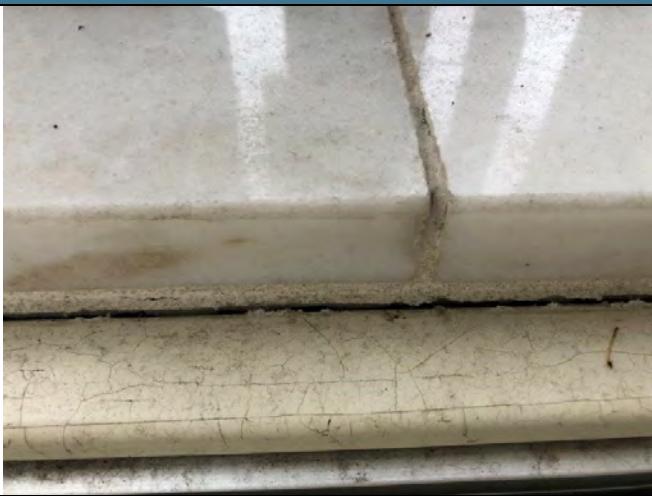
Photograph #15

HA-15: Grout/mortar - light grey mortar for granite window sill

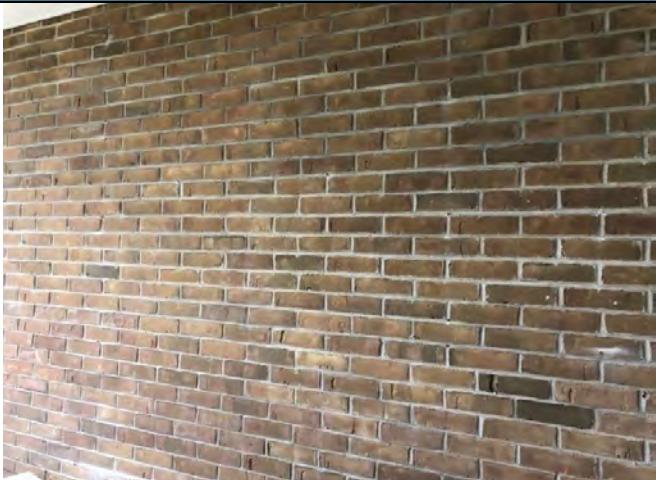
Photograph #16

HA-16: Brick mortar - brown brick mortar - grey

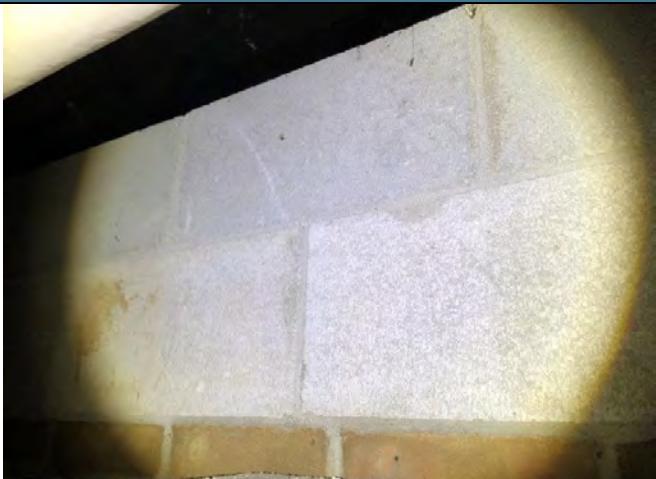
Photograph #17

HA-17: Block mortar - CMU block mortar

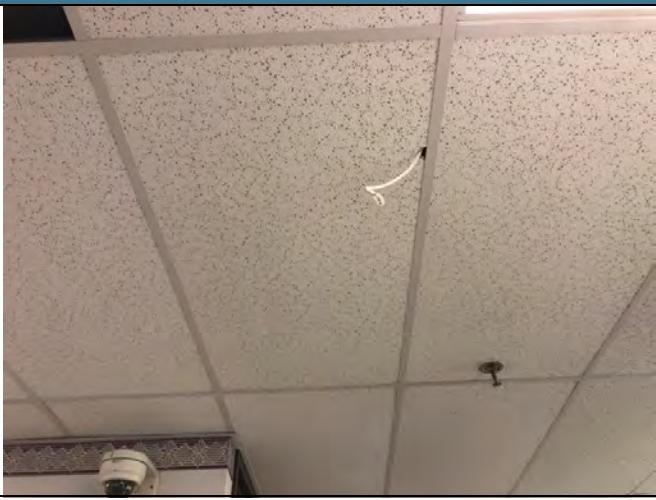
Photograph #18

HA-18: Ceiling panel - 2'x4' white panel with pinhole/fissure texture

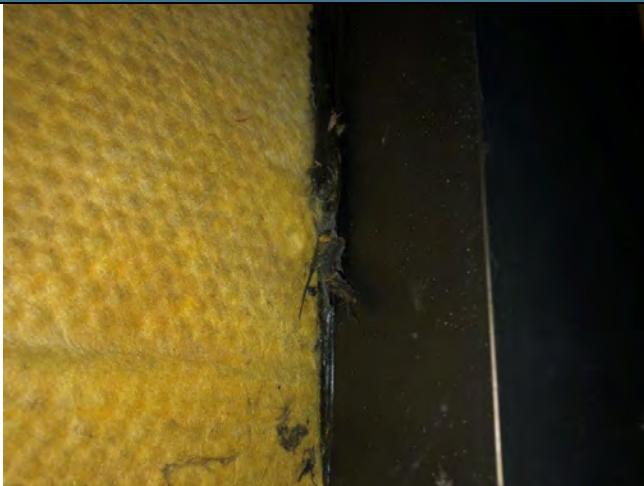
Photograph #20

HA-20: Interior caulk - dark grey, soft, sticky, seams of fiberglass panel insulation

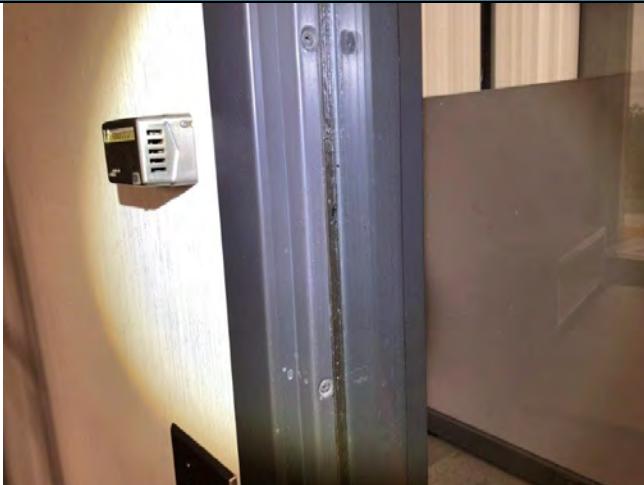
Photograph #21

HA-21: Window glaze - black, soft, on metal framed door/window systems

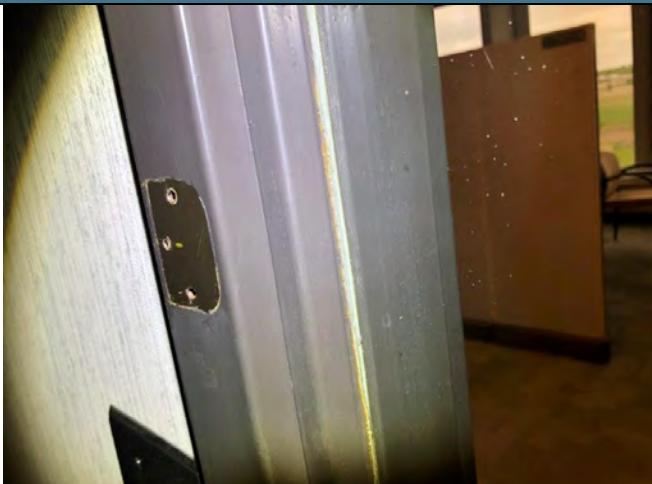
Photograph #22

HA-22: Window glaze - grey, hard, on metal framed door/window systems

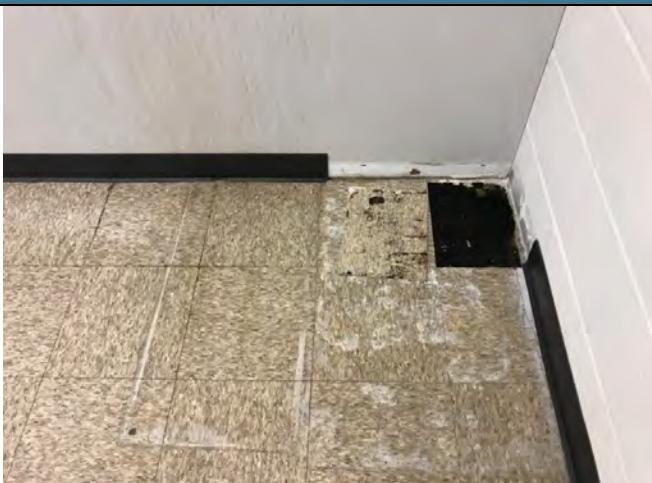
Photograph #23

HA-23: Floor tile- 12" brown mottle tile with black mastic

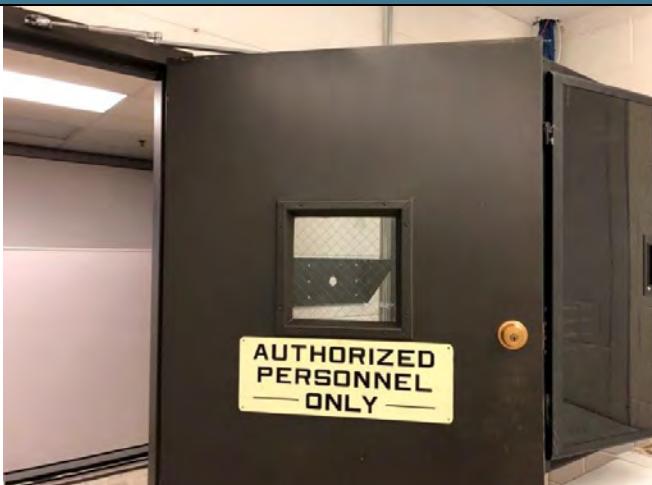
Photograph #24

HA-24: Window glaze - beige, on door window

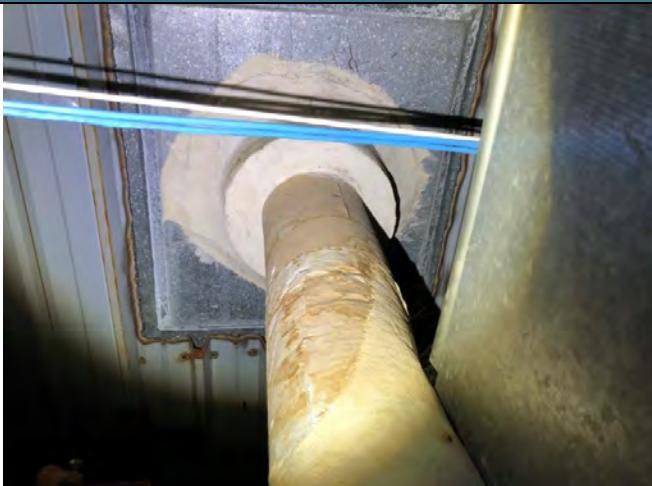
Photograph #26

HA-26: Roof drain fitting - canvas covered mudded fitting

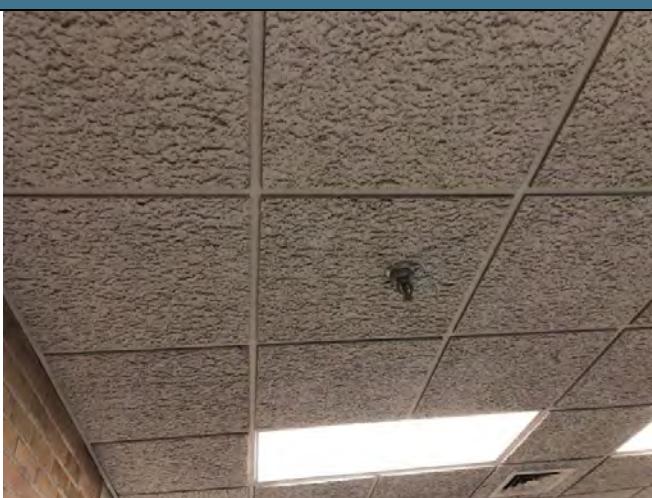
Photograph #27

HA-27: Ceiling panel - 2' white tile with rough texture

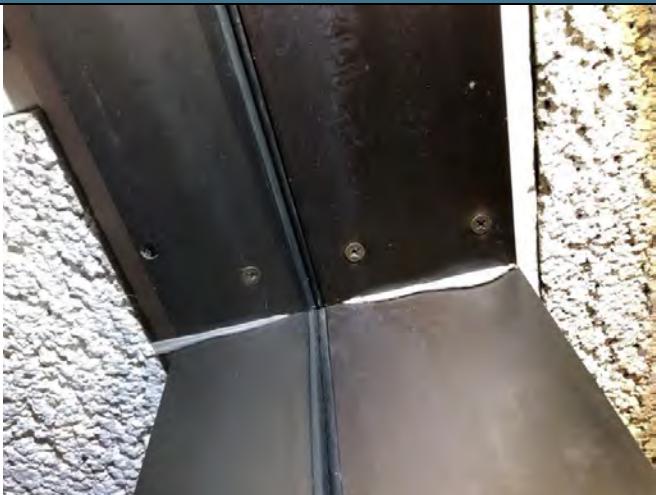
Photograph #28

HA-28: Interior caulk - light grey, seams of aluminum window/door wall system

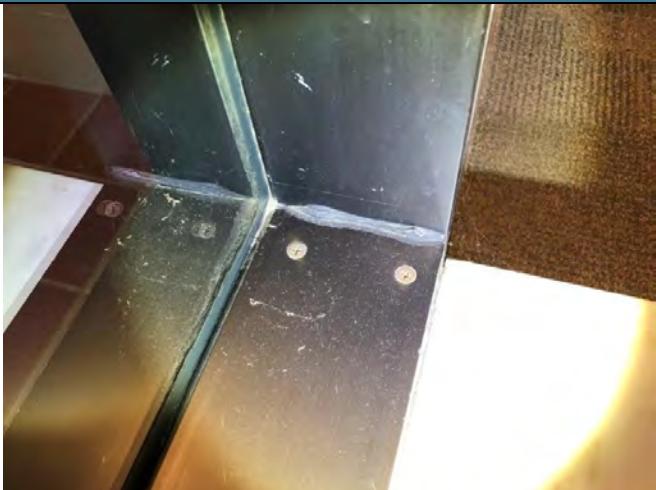
Photograph #29

HA-29: Interior caulk - black, seams and perimeter of aluminum window/door wall

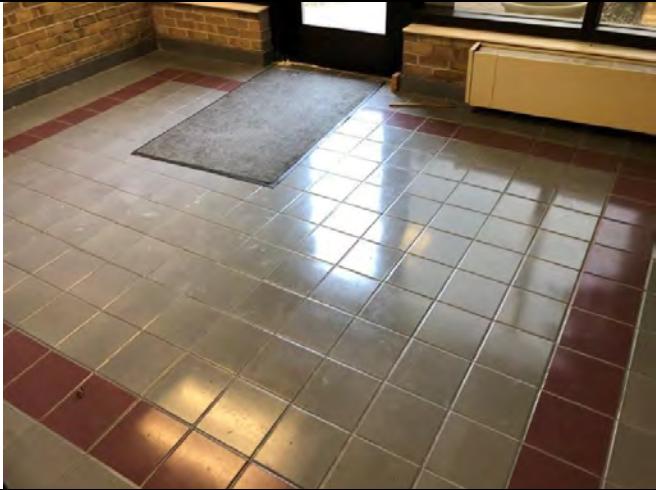
Photograph #30

HA-30: Grout/mortar - 8" grey and red floor tile

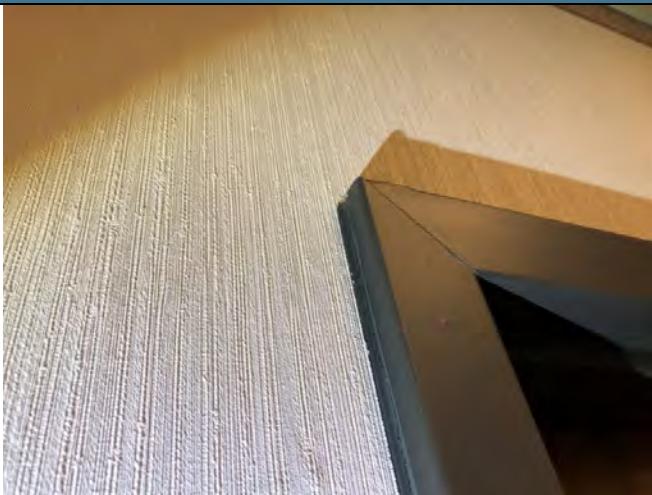
Photograph #31

HA-31: Interior caulk - black, soft, perimeter of metal door frames

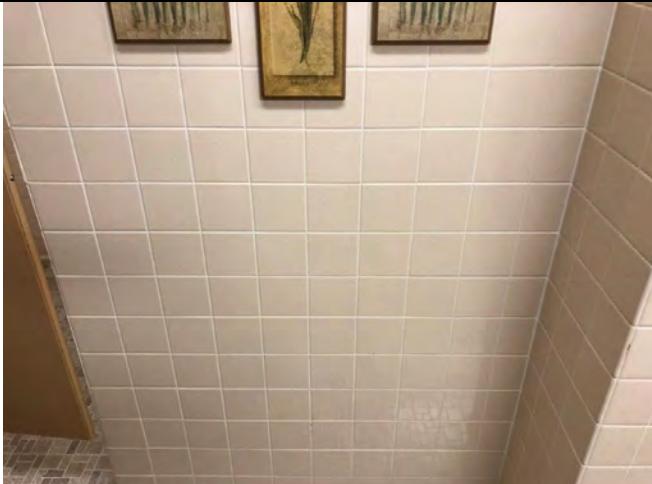
Photograph #32

HA-32: Grout/mortar - 4" beige wall tile

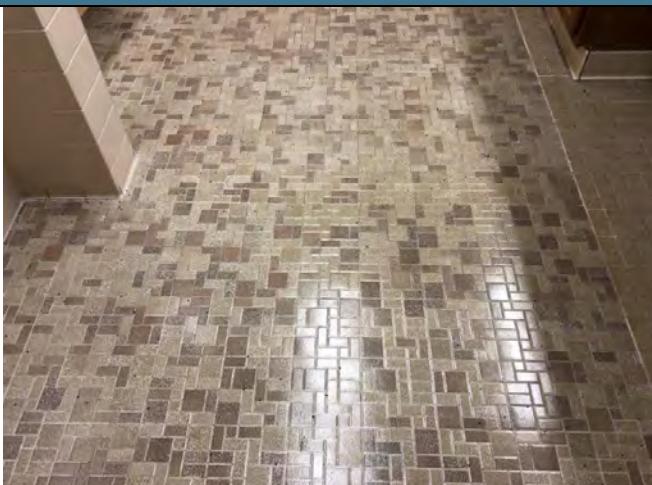
Photograph #33

HA-33: Grout/mortar - 1" and 2" brown floor tile

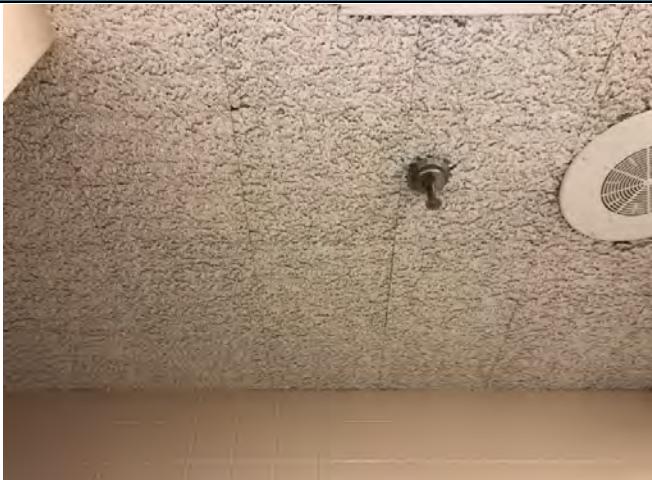
Photograph #34

HA-34: Ceiling tile - 12" white, rough texture

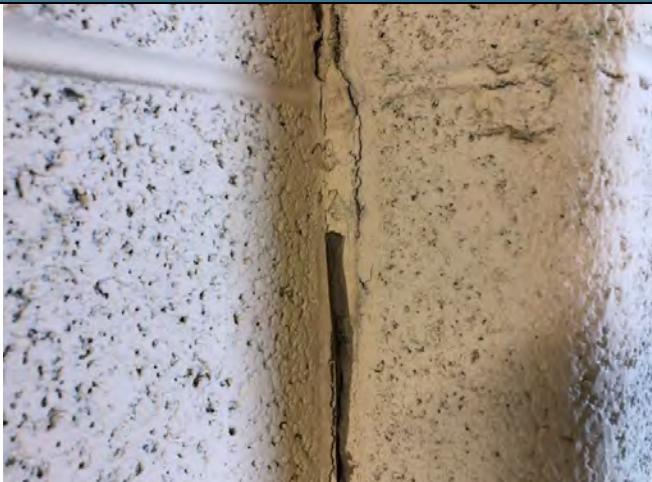
Photograph #36

HA-36: Interior caulk - grey, hard, corner seams of CMU block wall

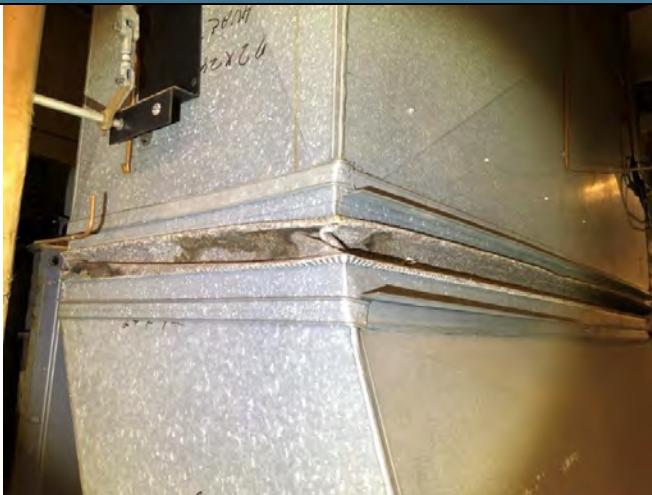
Photograph #37

HA-37: Vibration dampener - white cloth

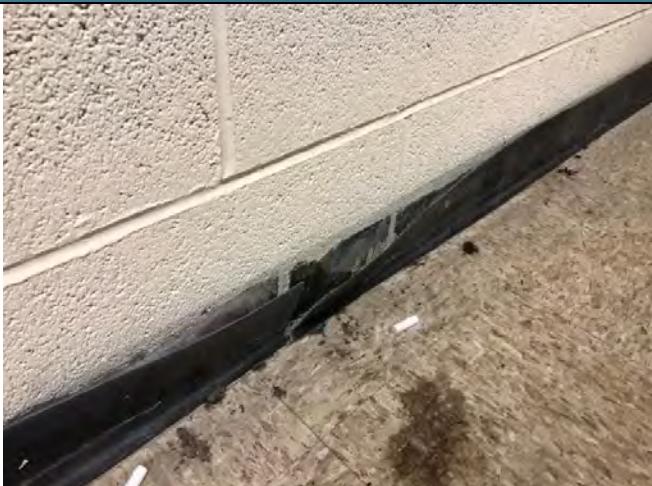
Photograph #38

HA-38: Cove base - 4" black with adhesive

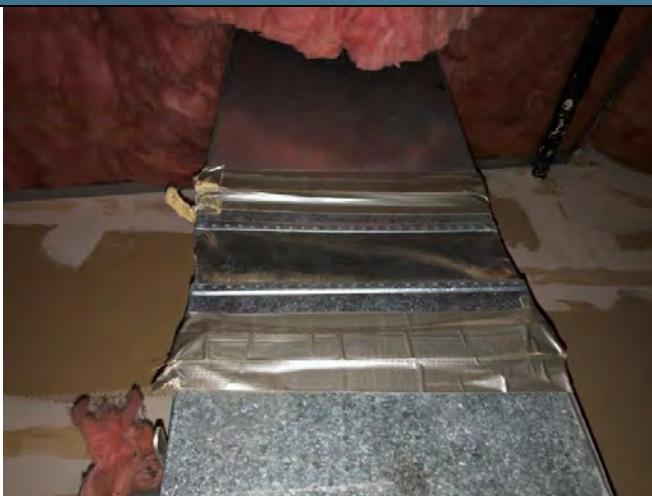
Photograph #39

HA-39: Vibration dampener - black vinyl

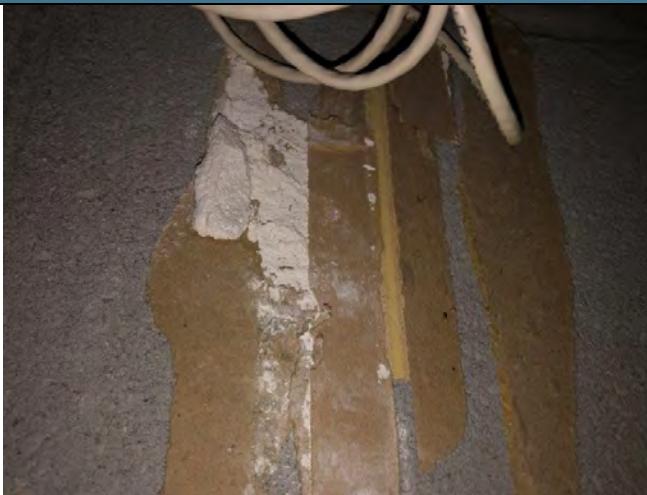
Photograph #40

HA-40: Construction adhesive - brown

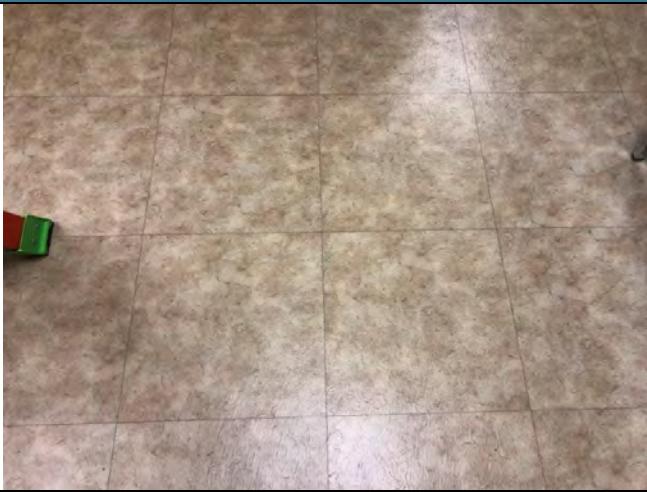
Photograph #41

HA-41: Multi-layer floor

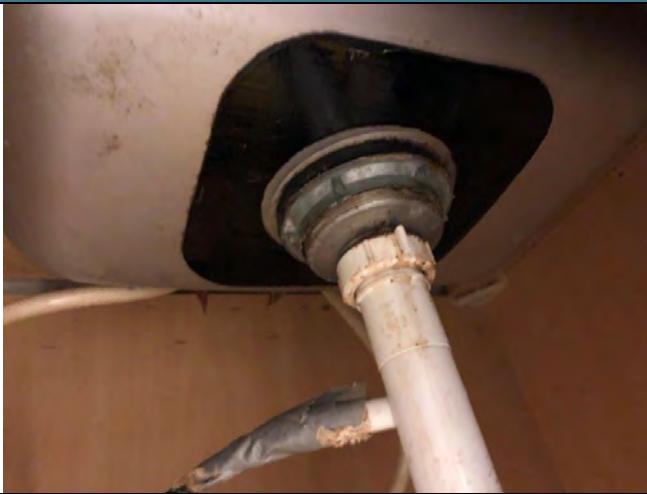
Photograph #42

HA-42: Sink undercoating - black stick-on

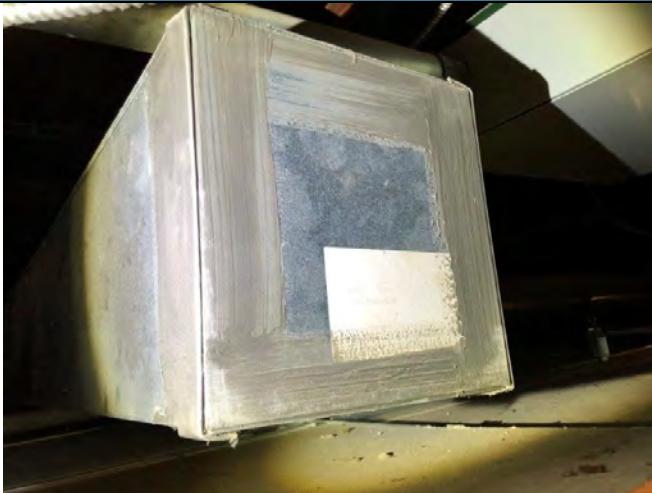
Photograph #43

HA-43: Interior caulk - grey duct caulk

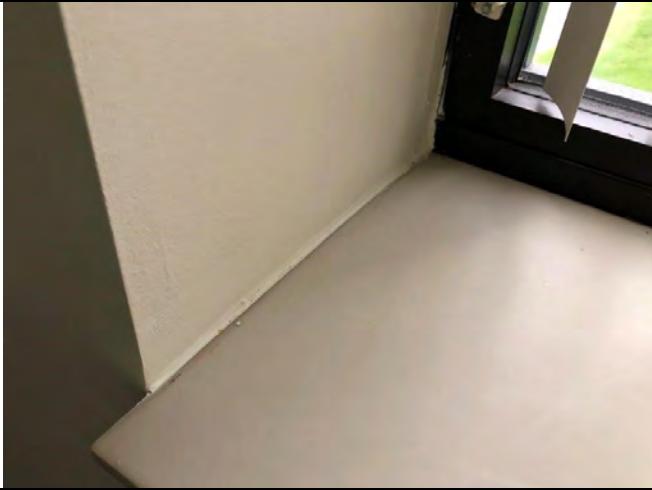
Photograph #44

HA-44: Interior caulk - white, soft, perimeter of off-white window sill

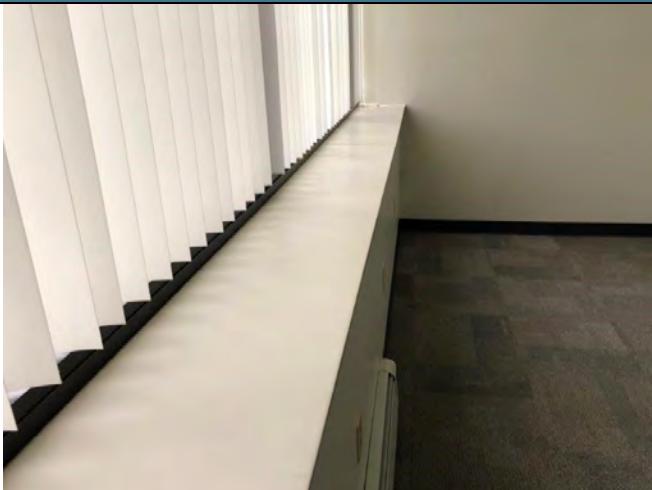
Photograph #45

HA-45: Window sill - off-white composite and adhesive

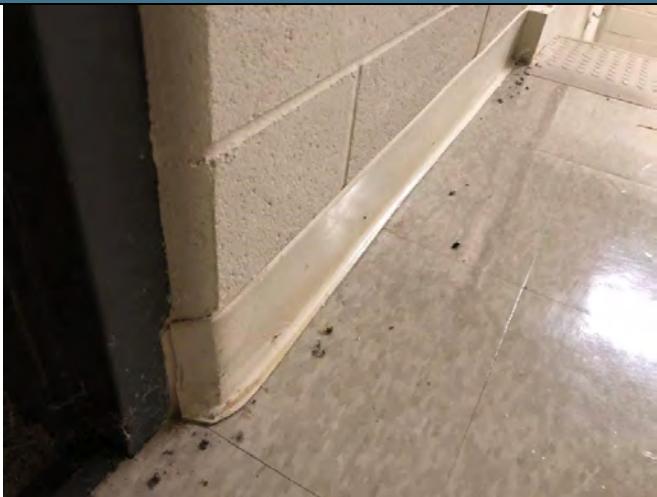
Photograph #46

HA-46: Cove base 4" crème vinyl and adhesive

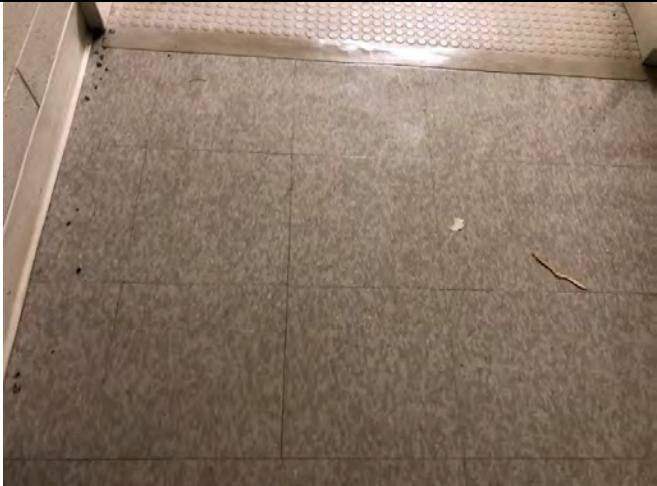
Photograph #47

HA-47: Floor tile -12" grey mottle tile, mastic

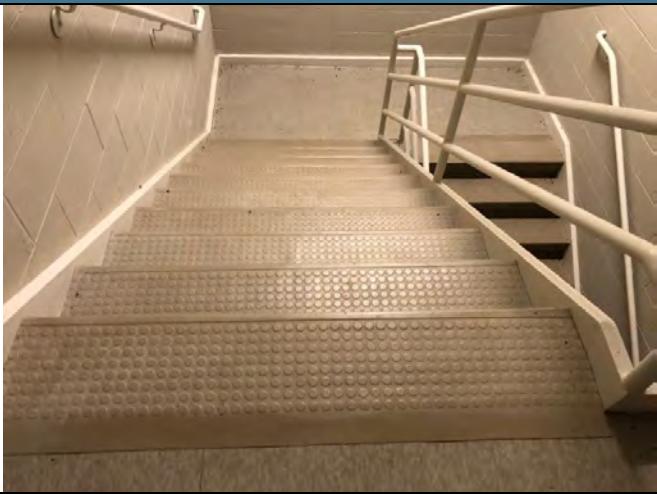
Photograph #48

HA-48: Stair tread - grey vinyl with adhesive

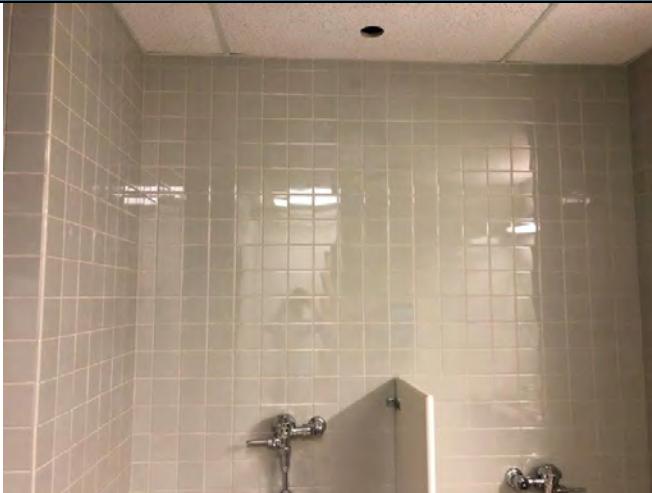
Photograph #49

HA-49: Grout/mortar - 4" mint wall tile

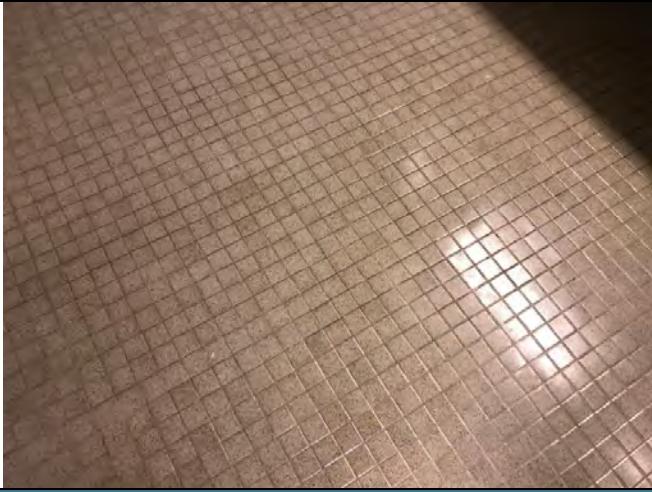
Photograph #50

HA-50: Grout/mortar - 2" grey floor tile

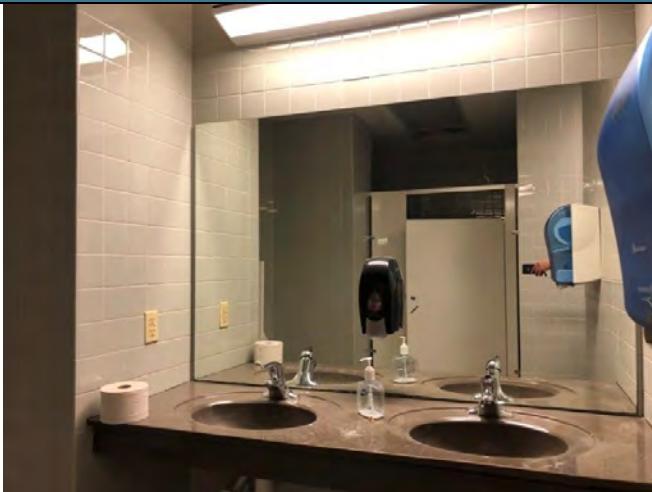
Photograph #51

HA-51: Construction adhesive - behind mirror

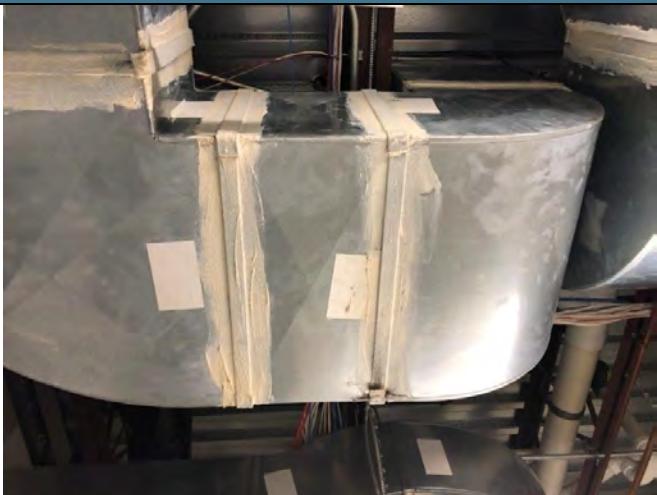
Photograph #52

HA-52: Interior caulk - white duct caulk

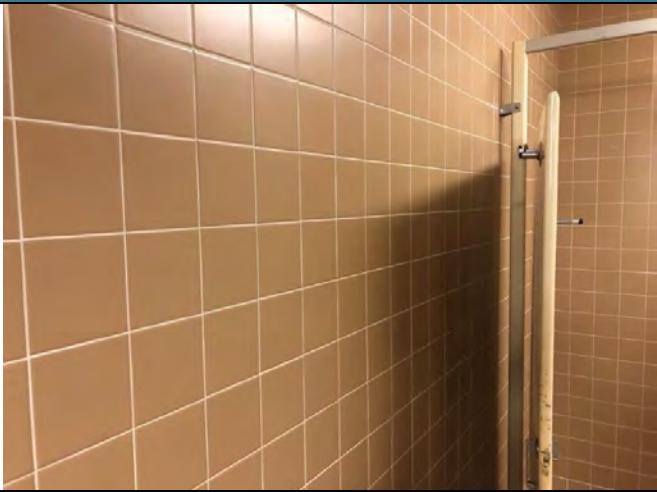
Photograph #53

HA-53: Grout/mortar - 4" brown wall tile

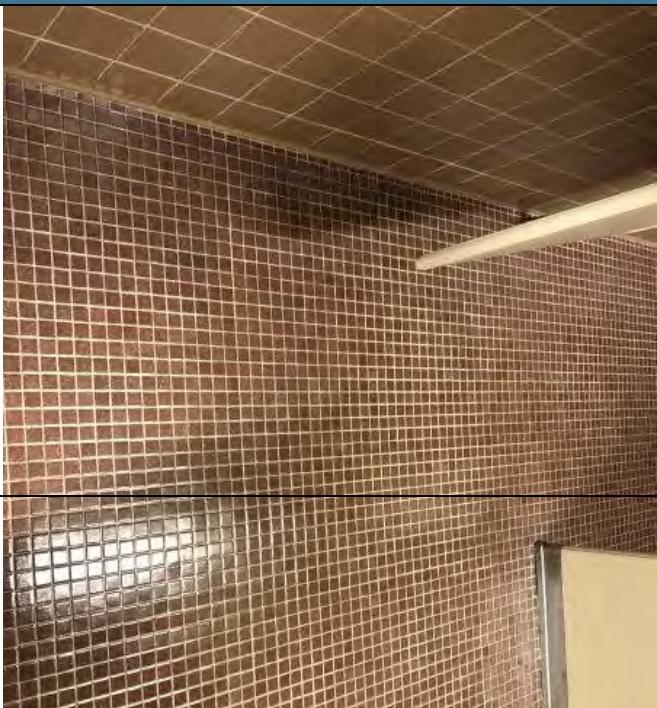
Photograph #54

HA-54: Grout/mortar - 1" red floor tile

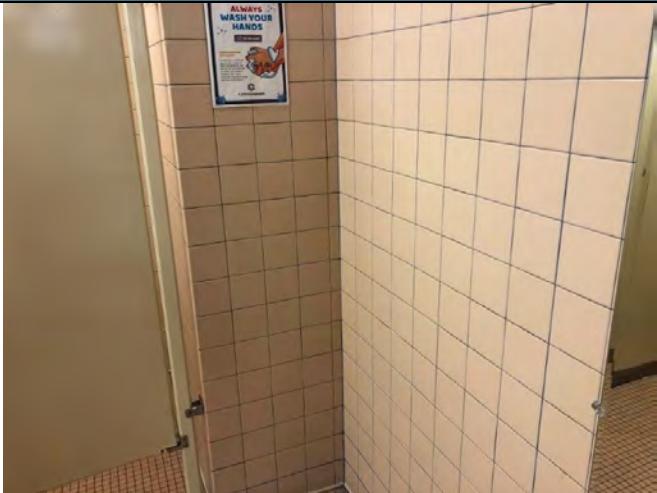
Photograph #55

HA-55: Grout/mortar - 4" peach wall tile

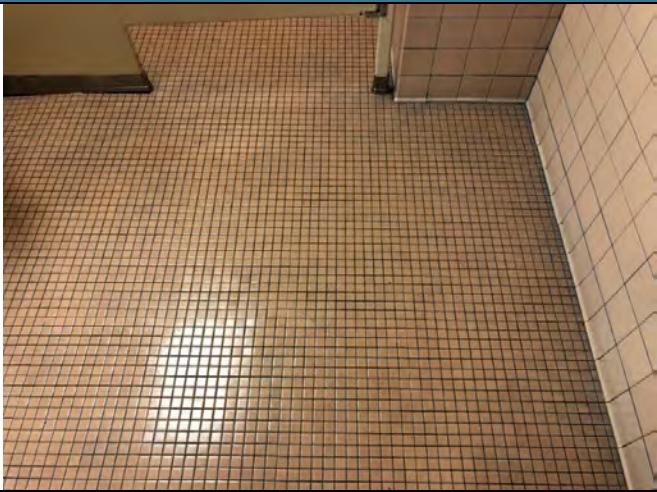
Photograph #56

HA-56: Grout/mortar - 1" peach floor tile

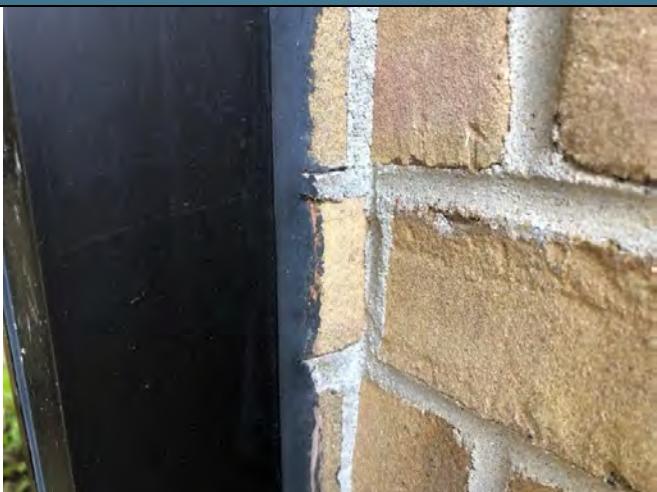
Photograph #57

HA-57: Exterior caulk - black, perimeter of aluminum door/window frames

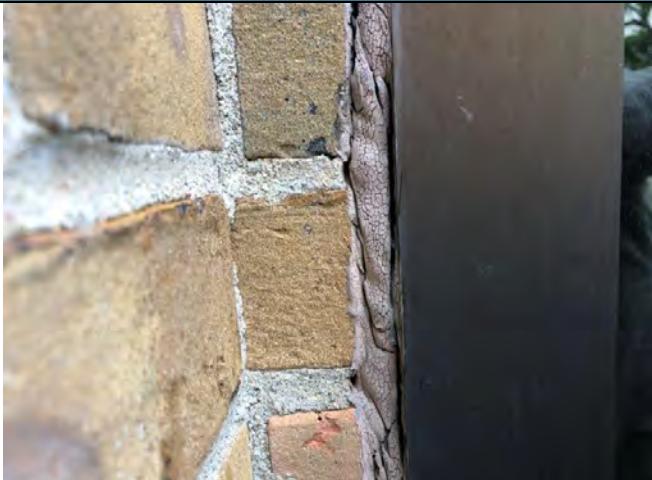
Photograph #58

HA-58: Exterior caulk - brown, alligator cracking texture perimeter of aluminum window frames

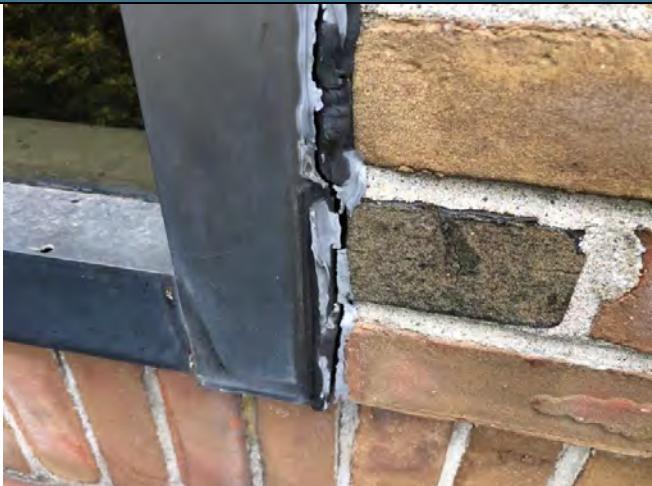
Photograph #59

HA-59: Exterior caulk - brown, dark grey, perimeter of aluminum window frames

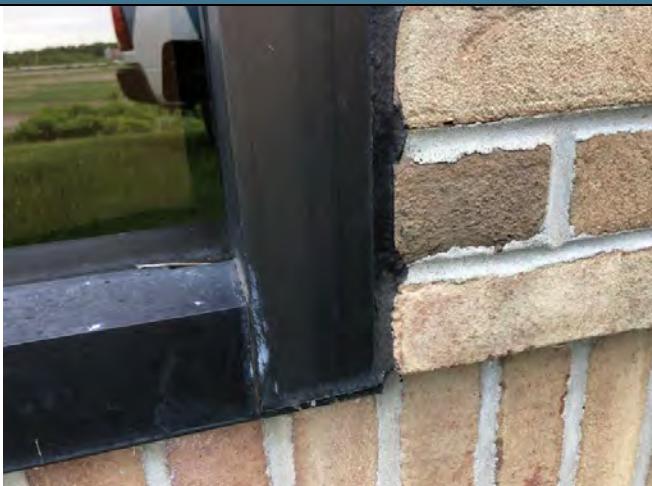
Photograph #60

HA-60: Window glaze - black, aluminum window frames

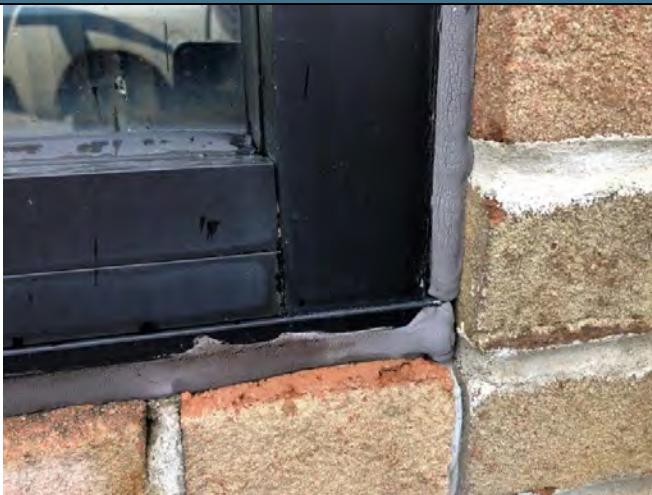
Photograph #61

HA-61: Exterior caulk - grey, perimeter of aluminum door/window frames

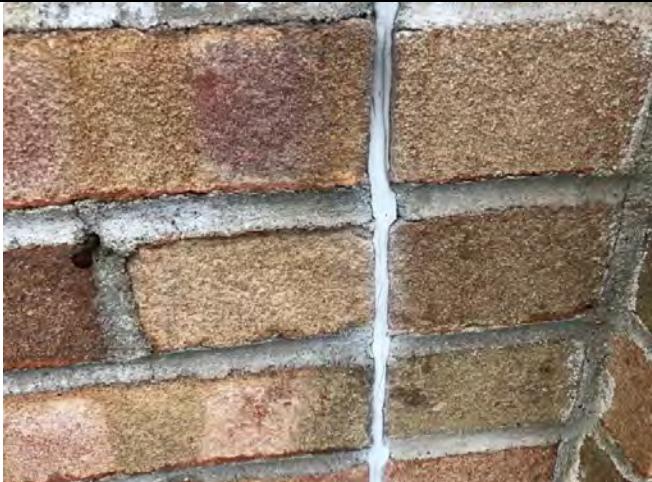
Photograph #62

HA-62: Exterior caulk - grey, wall penetrations, seams of brick joints

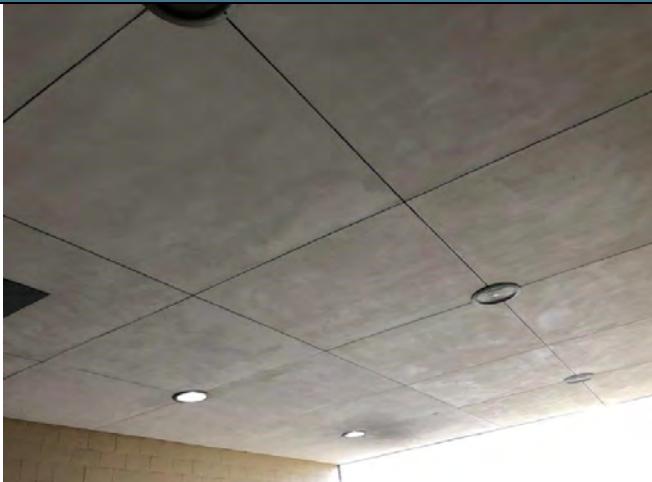
Photograph #63

HA-63: Plaster ceiling - vestibule ceiling

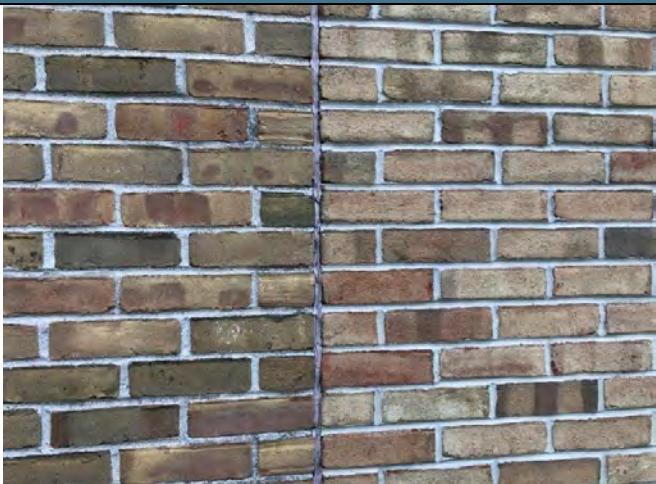
Photograph #64

HA-64: Expansion joint - brown, between brick seams

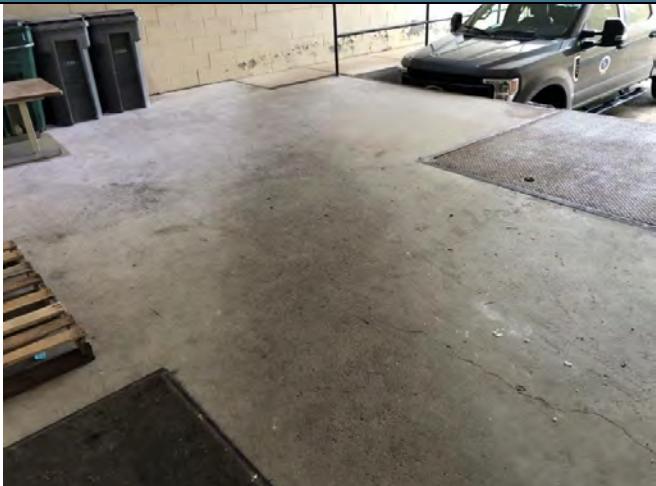
Photograph #65

HA-65: Concrete chip - exterior walk/drive ways

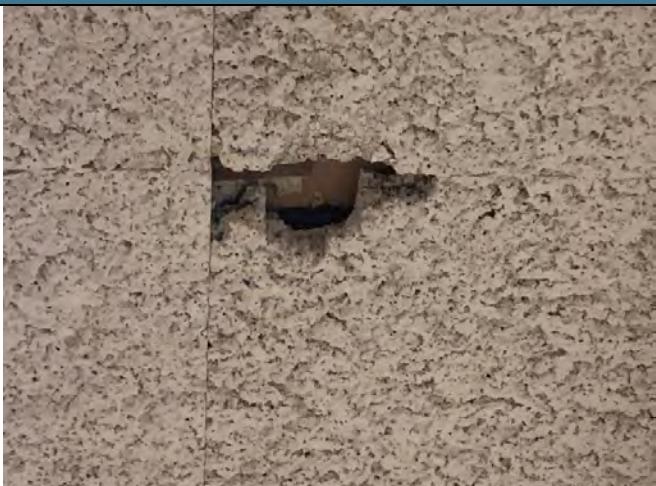
Photograph #66

HA-66: Glue pod - under ceiling tile
