**PRE-RENOVATION LIMITED ASBESTOS AND LEAD-CONTAINING PAINT SURVEY
WATERFORD ARMORY**

2650 WATKINS LAKE ROAD
JACKSON, MI 48328

Project #188BS25305

June 19, 2025

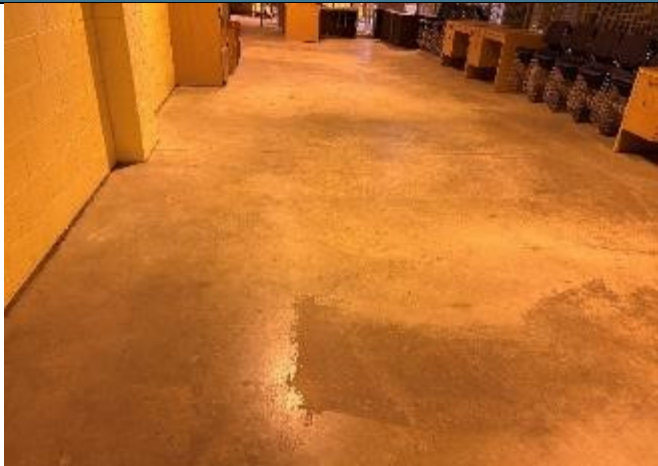
Photograph #1

Homogenous Material Description
	HA-1: Poured Concrete Floors
	Asbestos Present (Yes/No/Assumed)
	No
	Total Quantity Present
	20,531 SF
	Additional Notes
Photograph #2

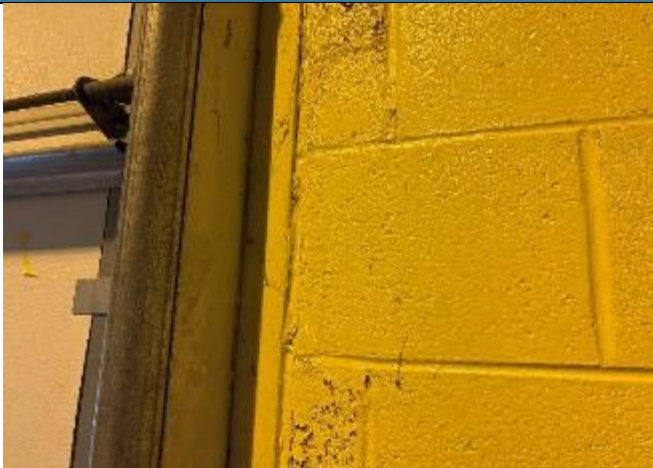
Photograph #7

HA-7: Grey Interior Door Caulk

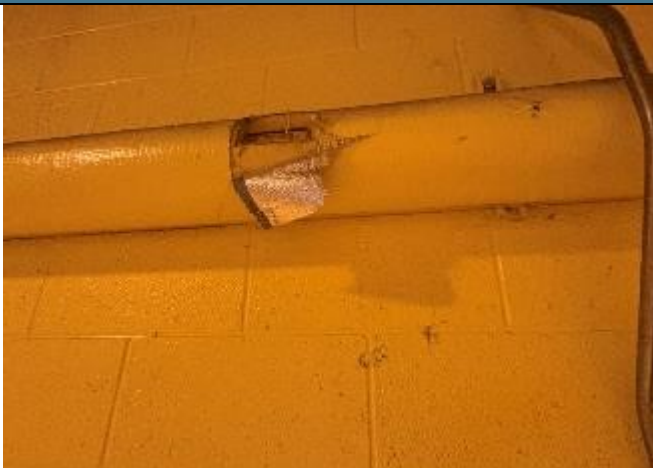
Photograph #8

HA-8: Fiberglass Pipe Insulation

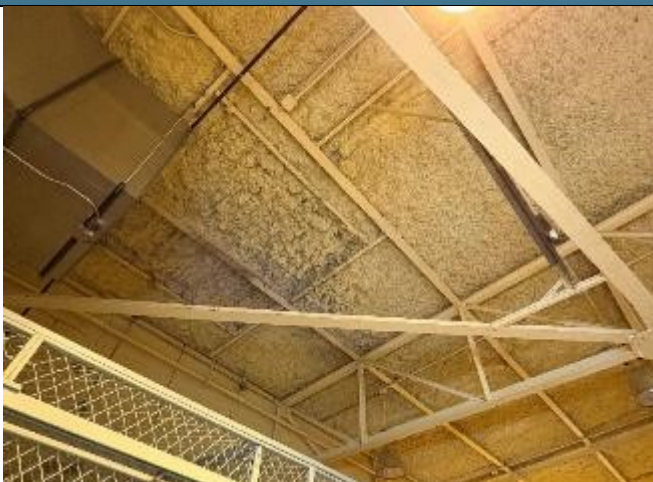
Photograph #9

HA-9: Yellow Painted White, Fluffy Spray on Insulation

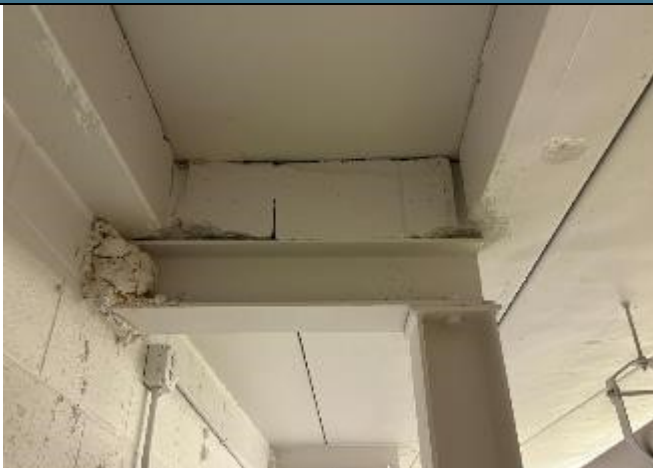
Photograph #17

HA-17: Concrete Ceiling

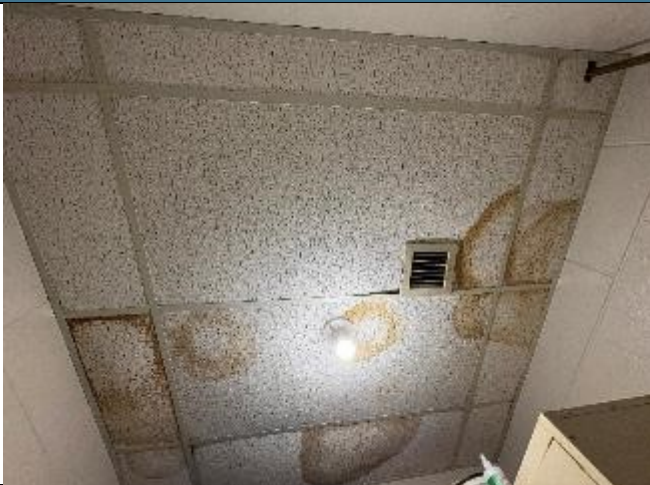
Photograph #25

HA-25: 2' x 4' Ceiling Panel with Pinholes and Long Gouges

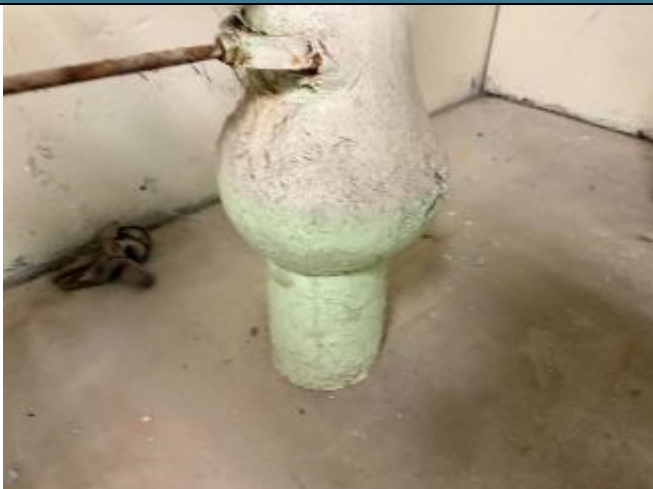
Photograph #62

HA-62: Mudded Fittings Associated with Fiberglass Straight Pipe Insulation

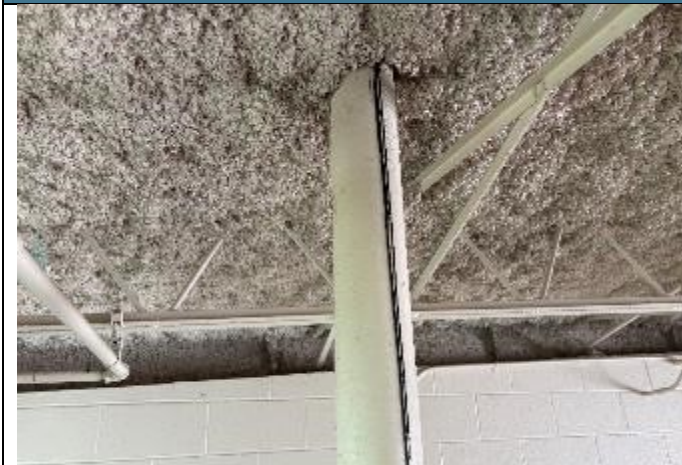
Photograph #84

HA-84: Outbuilding - Pink Spray-On Insulation

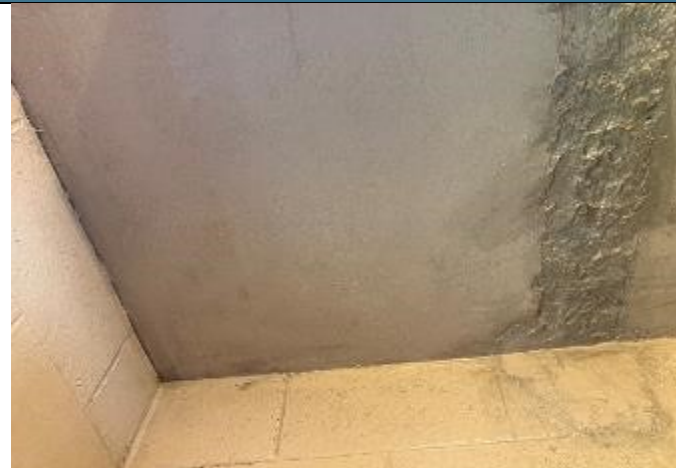
Photograph #94

HA-94: Outbuilding – Heat Shield

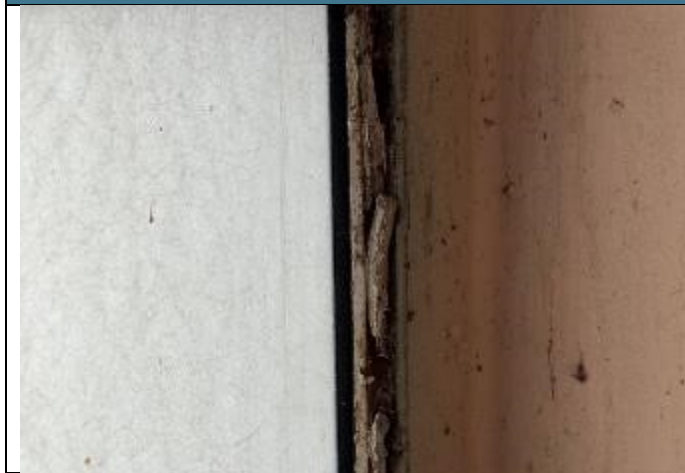
Photograph #97

Homogenous Material Description
HA-97: Outbuilding - Interior Second Floor Window Glaze
Asbestos Present (Yes/No/Assumed)
Point Count: 1.75% Chrysotile
Total Quantity Present
260 LF
Additional Notes
