**PRE-RENOVATION LIMITED ASBESTOS AND LEAD-CONTAINING PAINT SURVEY
JACKSON ARMORY**

2700 ARGYLE STREET
JACKSON, MI 49202

Project #188BS25298

June 6, 2025

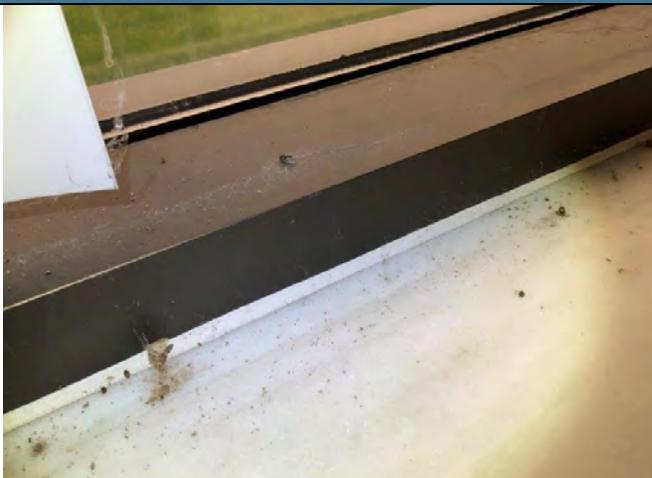
Photograph #13

HA-13: Interior caulk - bright white, soft, along bottom perimeter of aluminum window frame

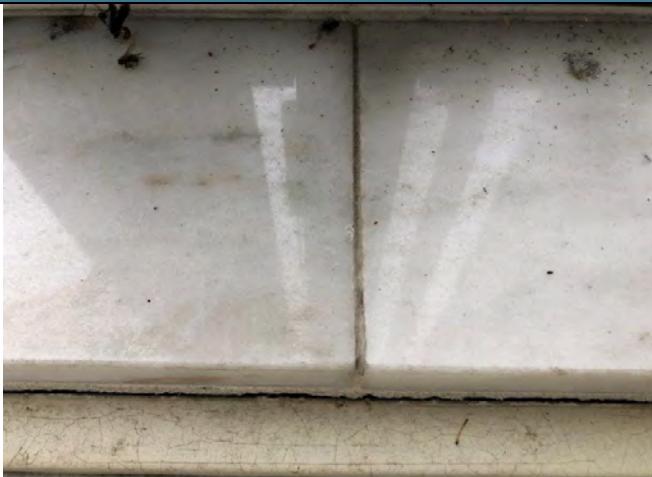
Photograph #14

HA-14: Interior caulk- white, crumbly, seams of granite window sill tile

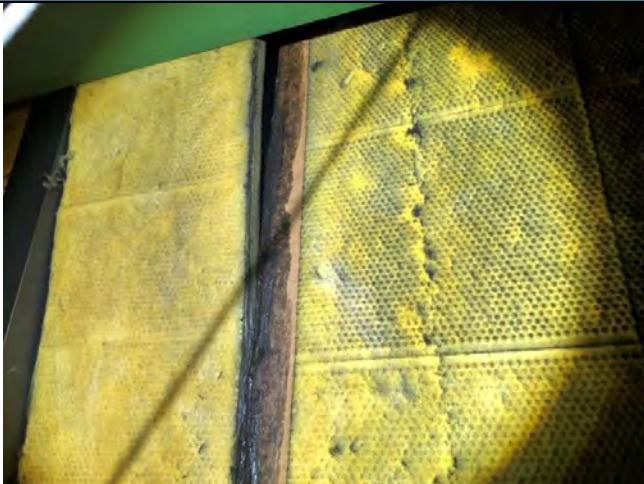
Photograph #19

HA-19: Panel insulation - fiberglass panel with black backing paper with tar adhesive
