**PRE-RENOVATION LIMITED ASBESTOS AND LEAD-CONTAINING PAINT SURVEY
WATERFORD ARMORY**

2650 WATKINS LAKE ROAD
JACKSON, MI 48328

Project #188BS25305

June 19, 2025

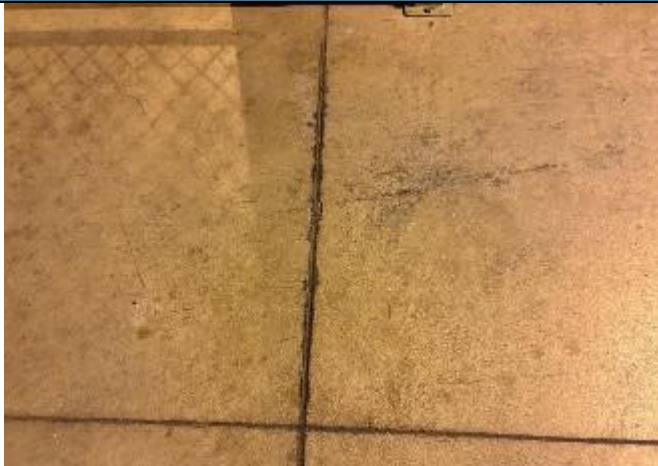
Homogenous Material Description
	HA-1: Poured Concrete Floors
	Asbestos Present (Yes/No/Assumed)
	No
	Total Quantity Present
	20,531 SF
	Additional Notes
Photograph #2

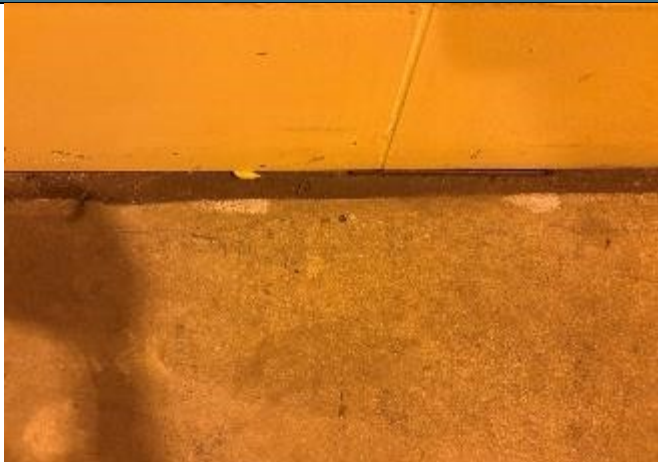
Homogenous Material Description
	HA-2: Concrete Floor Expansion Joint
	Asbestos Present (Yes/No/Assumed)
	No
	Total Quantity Present
	446 LF
	Additional Notes
Photograph #3

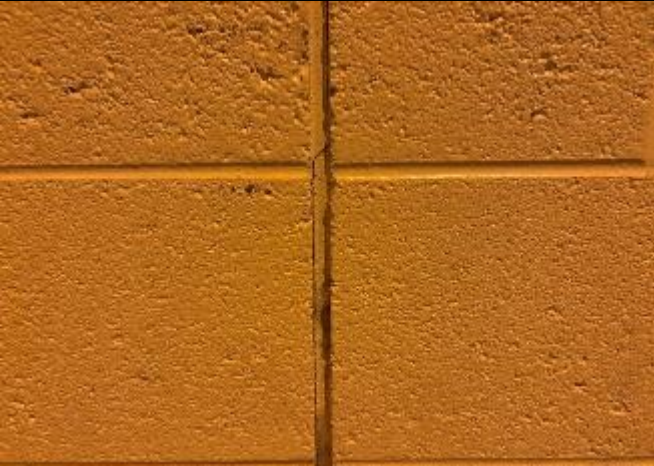
Homogenous Material Description
	HA-4: CMU Block Wall Mortar
	Asbestos Present (Yes/No/Assumed)
	No
	Total Quantity Present
	22,250 SF
	Additional Notes
Photograph #5

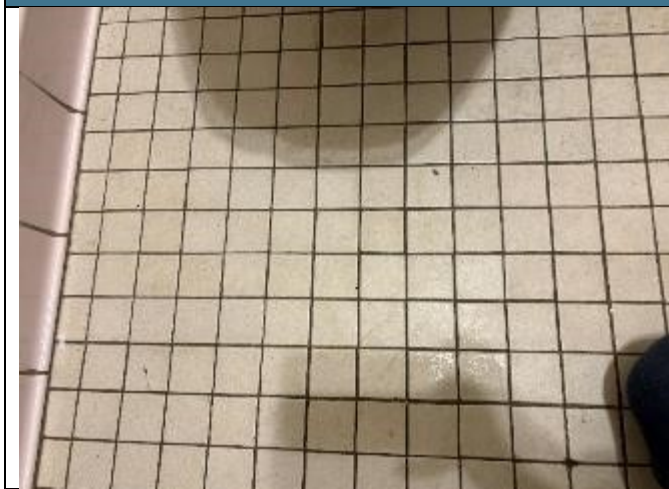
Homogenous Material Description
HA-31: 1" x 1" Off-White Ceramic Tile Floor and Grout
Asbestos Present (Yes/No/Assumed)
No
Total Quantity Present
145 SF
Additional Notes

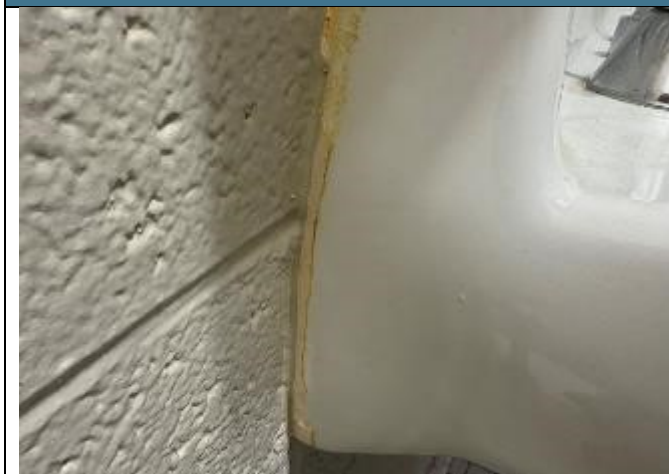
Homogenous Material Description
HA-32: Paper and Adhesive Under Plumbing Caulk
Asbestos Present (Yes/No/Assumed)
No
Total Quantity Present
235 SF
Additional Notes

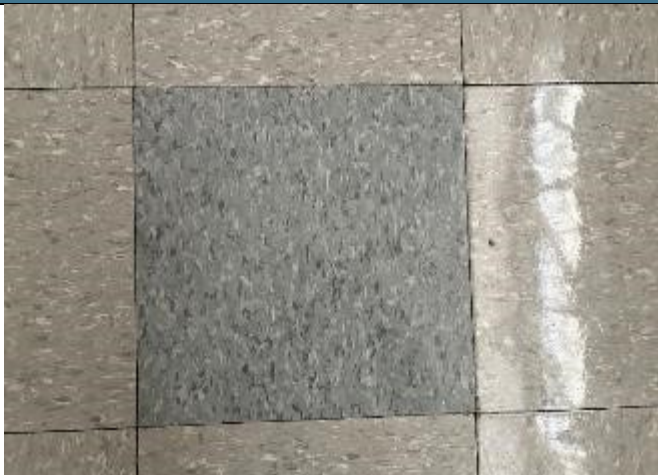
Homogenous Material Description
	HA-41: 12" x 12" Blue Mottled Floor Tile and Mastic
	Asbestos Present (Yes/No/Assumed)
	No
	Total Quantity Present
	102 SF
	Additional Notes
Photograph #42

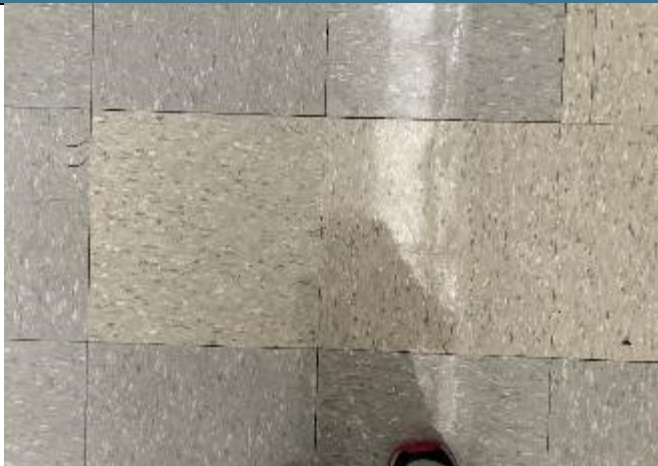
Homogenous Material Description
	HA-42: 12" x 12" Light Grey Mottled with White and Grey Streaks, Floor Tile and Mastic
	Asbestos Present (Yes/No/Assumed)
	No
	Total Quantity Present
	15 SF
	Additional Notes

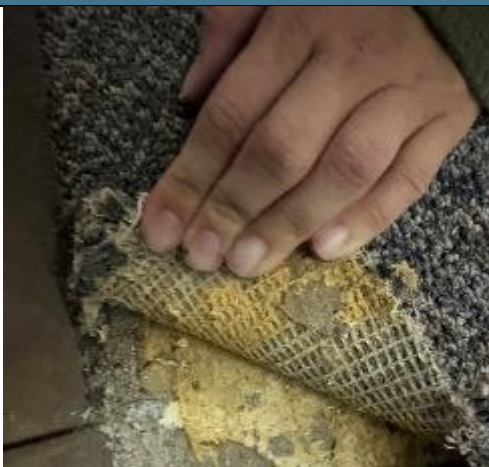
Photograph #45

HA-45: Yellow Carpet Mastic

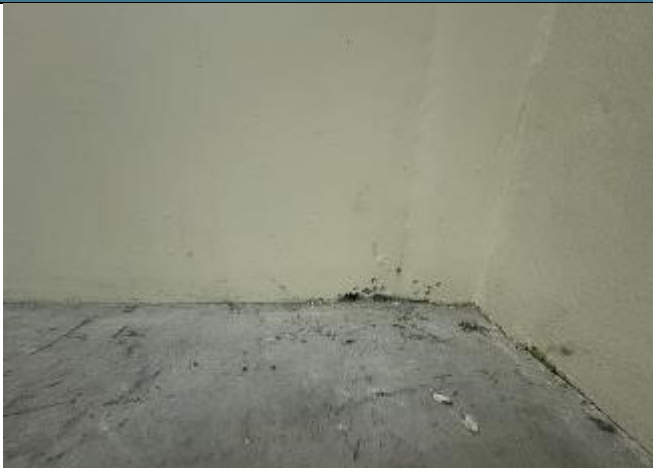
Photograph #46

HA-46: Concrete Wall

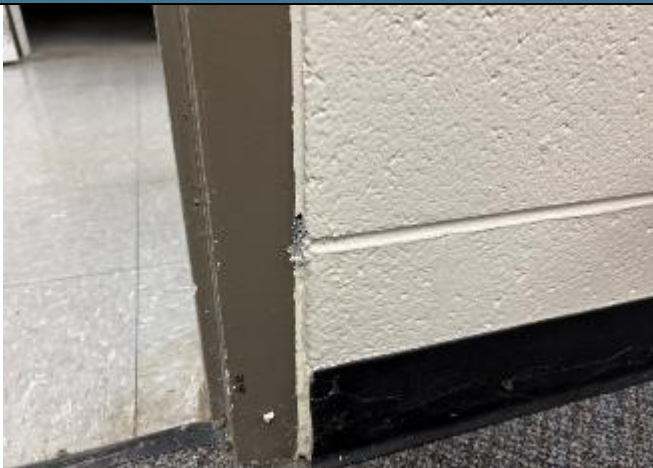
Photograph #47

HA-47: Interior Light Grey Building Caulk

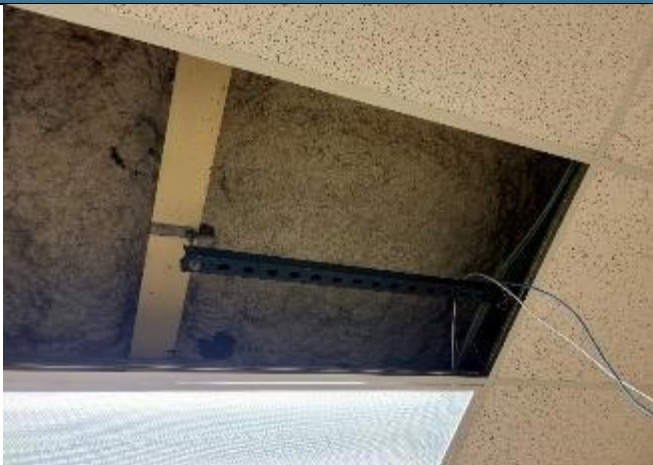
Photograph #48

HA-48: White Fluffy Spray-on Insulation

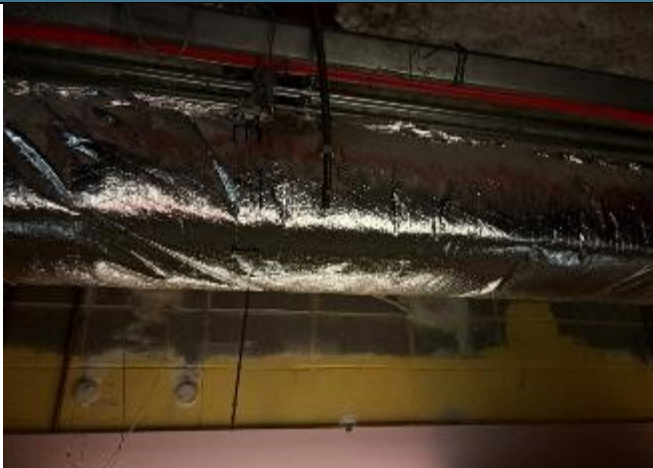
Photograph #49

HA-49: Silver Foil Wrapped Duct Insulation

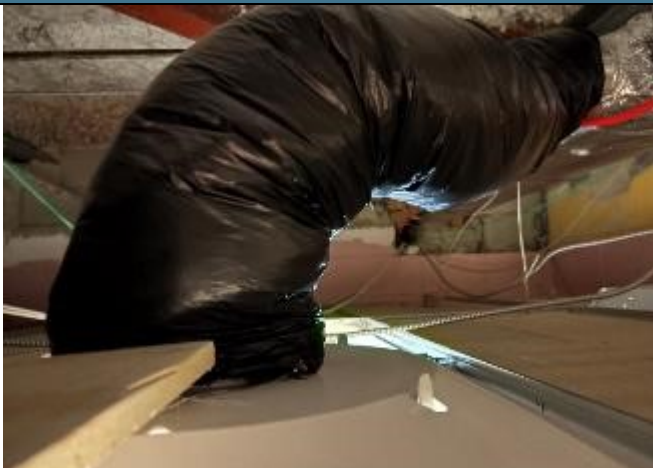
Photograph #50

HA-50: Black Plastic Wrapped Duct Insulation

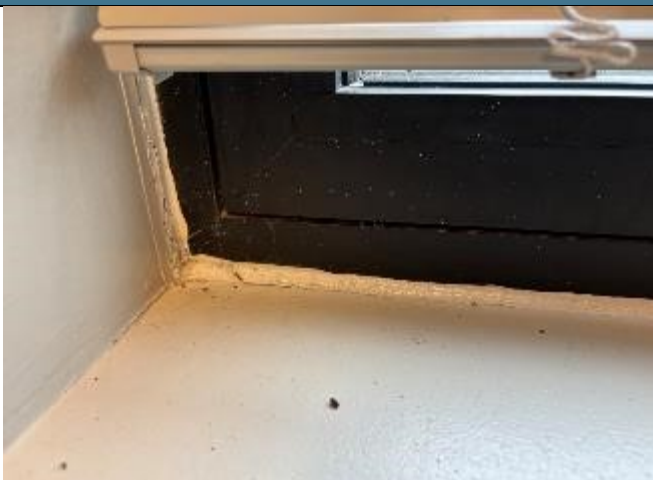
Photograph #51

HA-51: Interior White Multi-Layer Window
Caulk

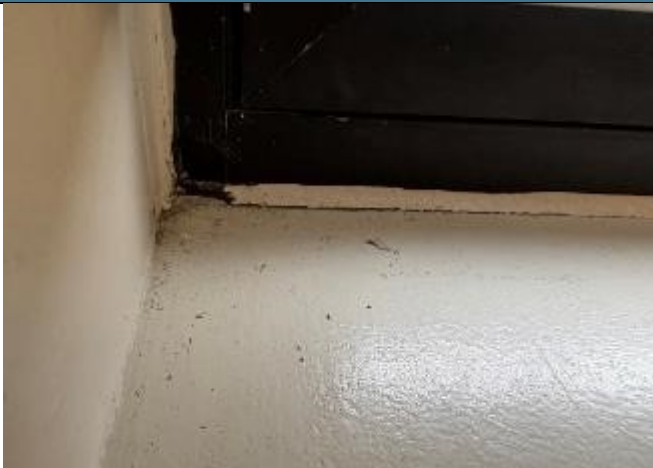
Photograph #52

HA-52: Interior Black Window Caulk

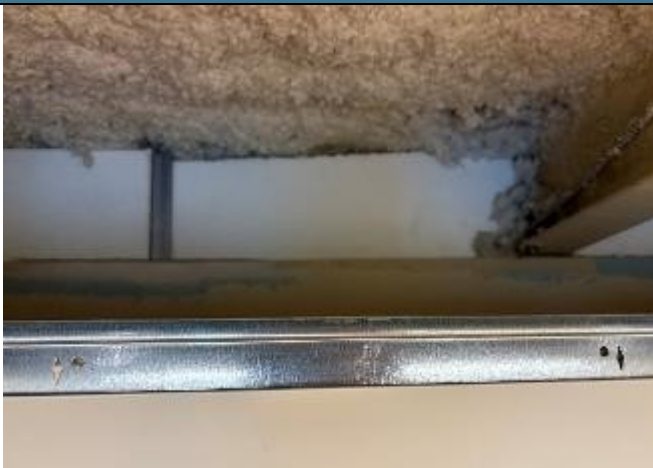
Photograph #53

HA-53: Styrofoam Wallboard Insulation

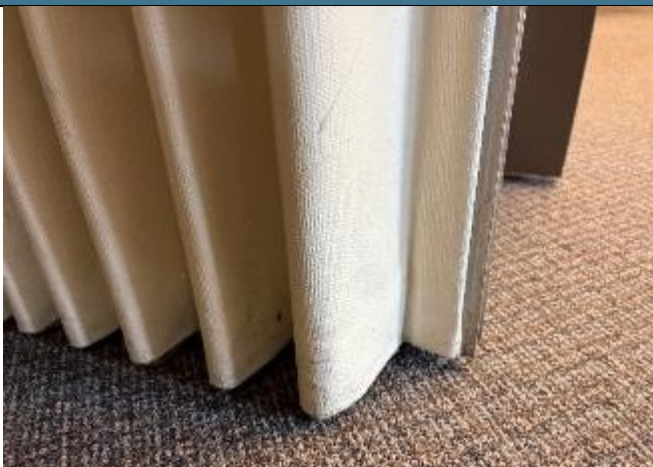
Photograph #54

HA-54: Accordion Dividing Wall

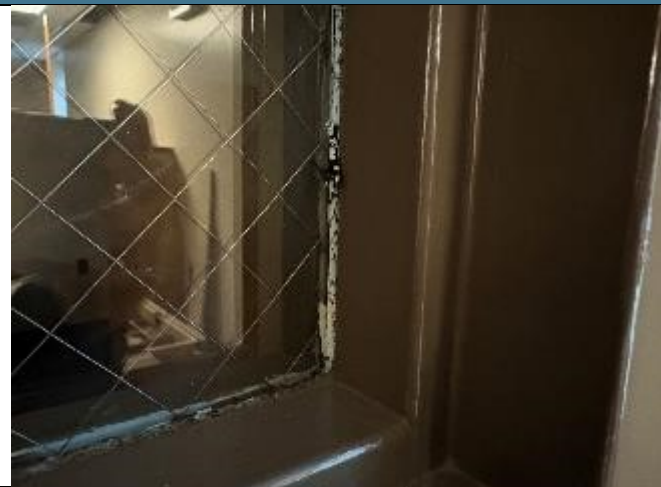
Photograph #55

HA-55: Interior Black Window Caulk Associated with Windows in Door Frames

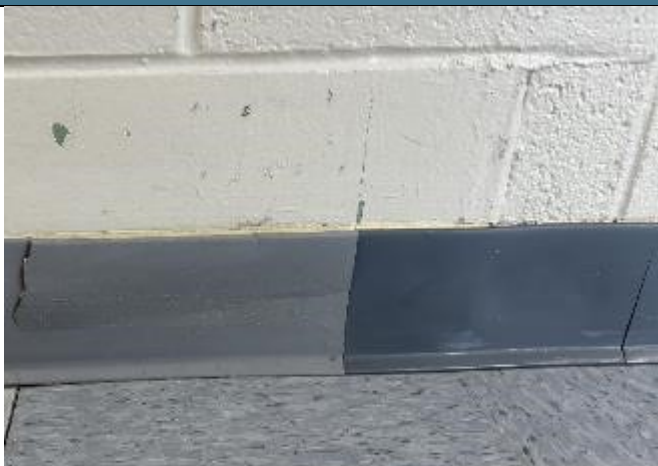
Photograph #59

Homogenous Material Description
	HA-59: 4" Blue Cove Base and Adhesive
	Asbestos Present (Yes/No/Assumed)
	No
	Total Quantity Present
	60 LF
	Additional Notes

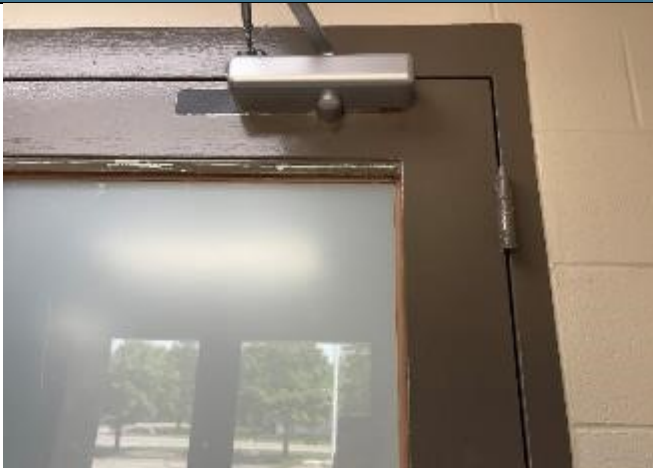
Photograph #61

HA-61: Interior, Orange, Door Window Caulk

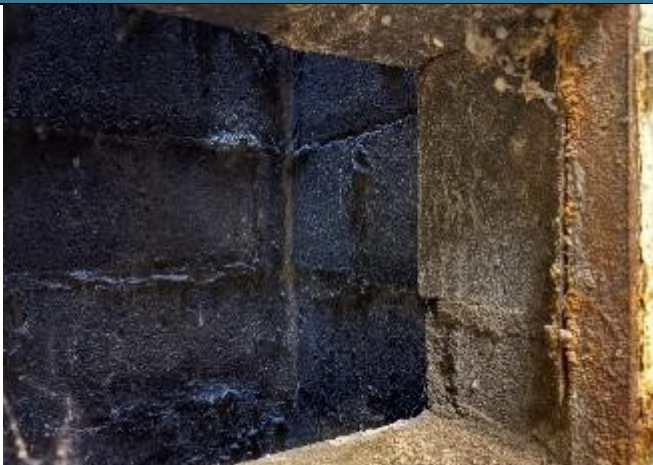
Photograph #63

HA-63: Chimney Brick and Mortar

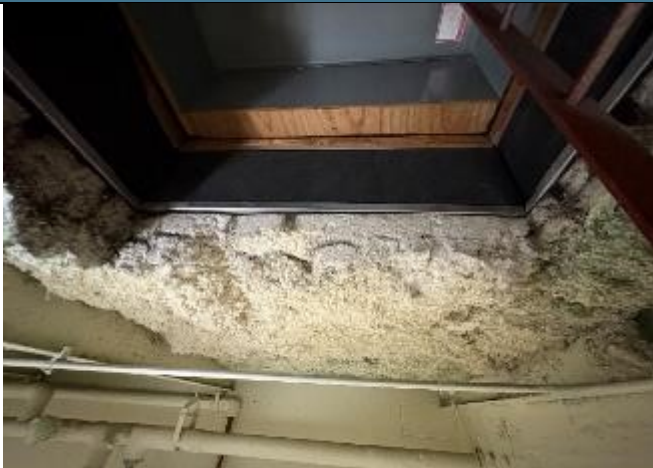
Photograph #64

HA-64: Black Weatherproofing

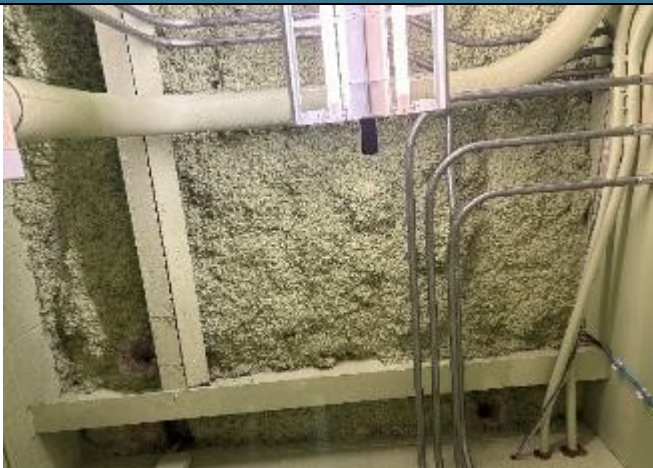
Photograph #65

HA-65: Green Spray-On Insulation

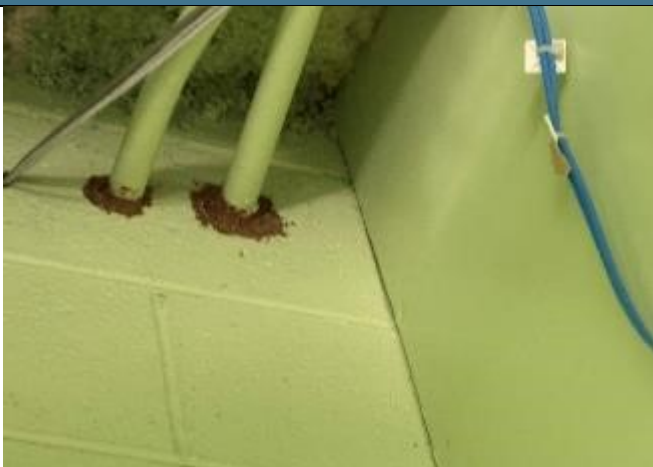
Photograph #66

HA-66: Interior Brown Firestop Caulk

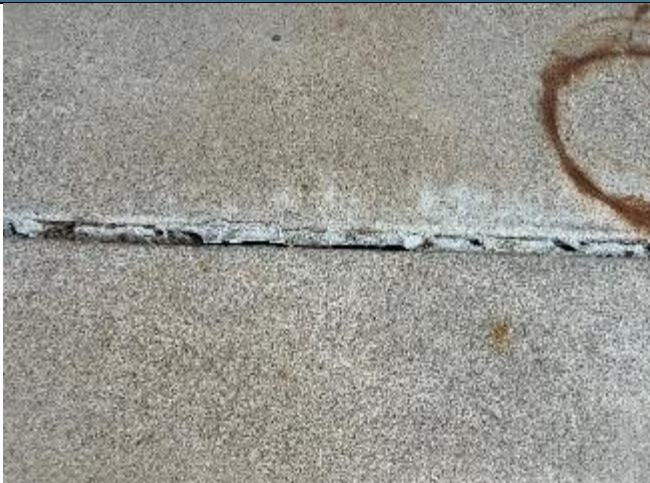
Photograph #67

HA-67: Exterior Light Grey Cement Sidewalk
Caulk

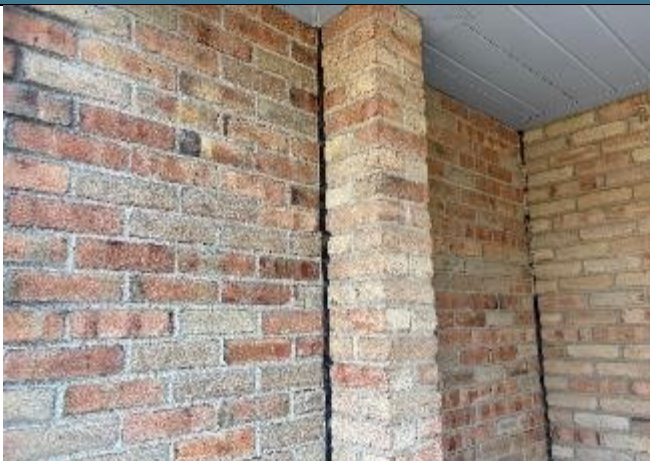
Photograph #68

68-EC-A,B,C	Main Building Exterior	Exterior Black Building Caulk	150 LF	Point Count: 1.25% Chrysotile
69-EC-A,B,C	Main Building Exterior	Exterior Medium Grey Metal Siding Caulk	5 LF	Point Count: 1.5% Chrysotile

HA-68: Exterior Black Building Caulk

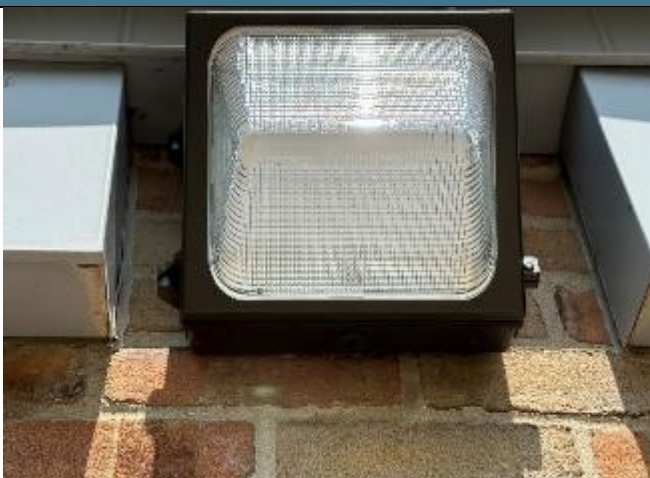
Photograph #69

HA-69: Exterior Medium Grey Metal Siding
Caulk

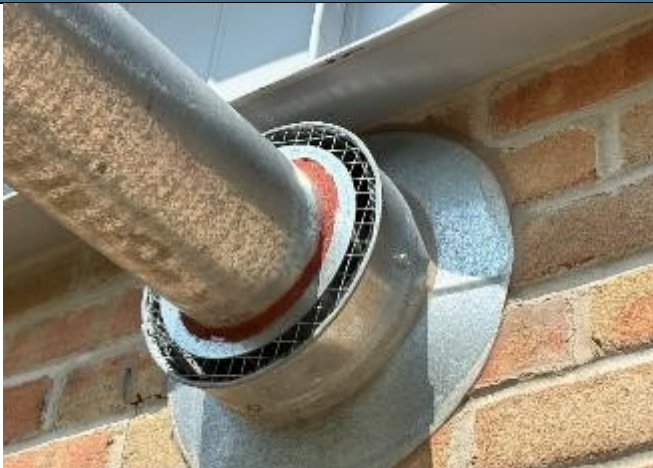
Photograph #70

HA-70: Exterior Red Fire-Stop Caulk

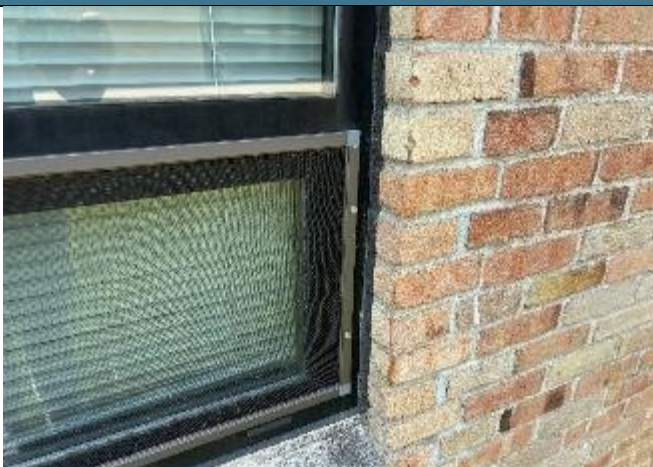
Photograph #72

HA-72: Exterior Black Window Caulk

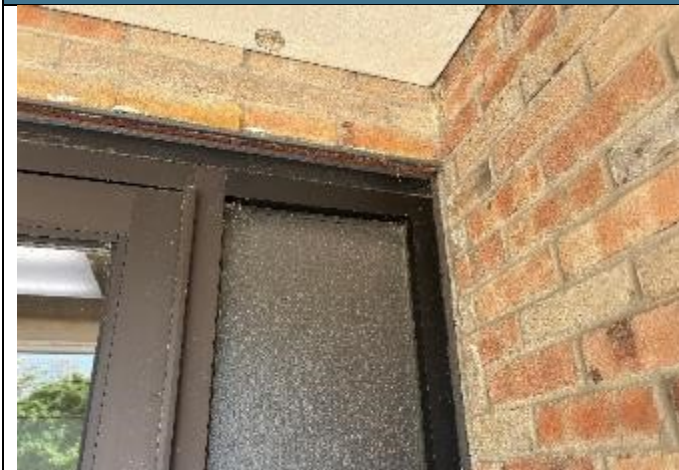
Photograph #73

HA-73: Exterior Black Door Caulk

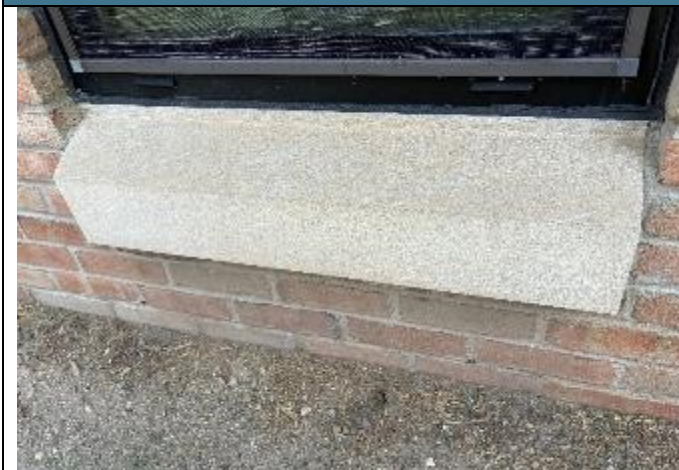
Photograph #74

HA-74: Exterior Cement Windowsills

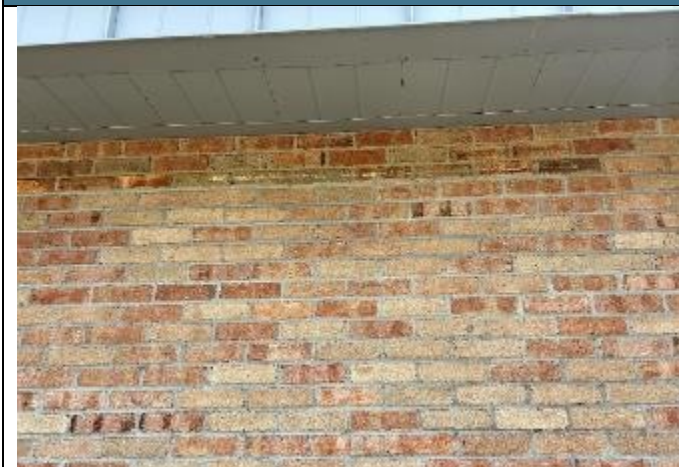
Photograph #75

HA-75: Exterior Brick and Mortar

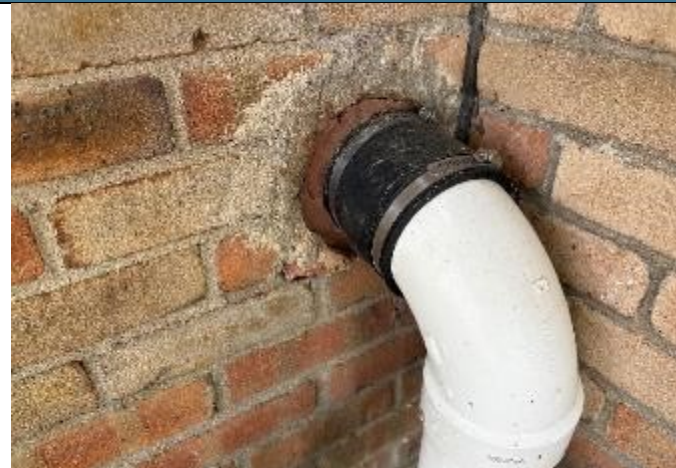
Photograph #76

HA-76: Exterior Brown Pipe Penetration Caulk

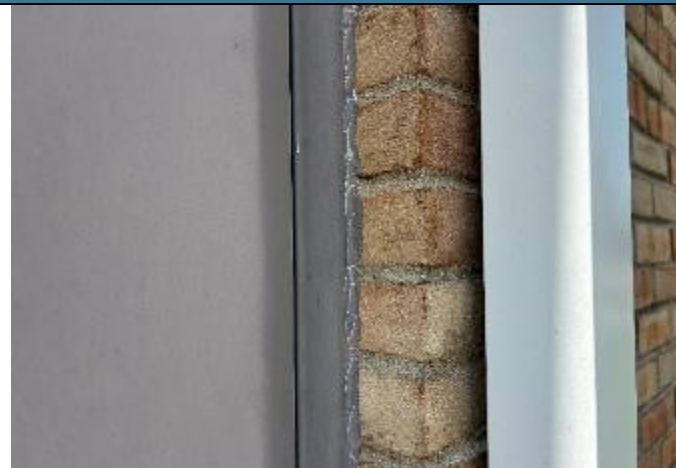
Photograph #77

HA-77: Exterior White Door Caulk

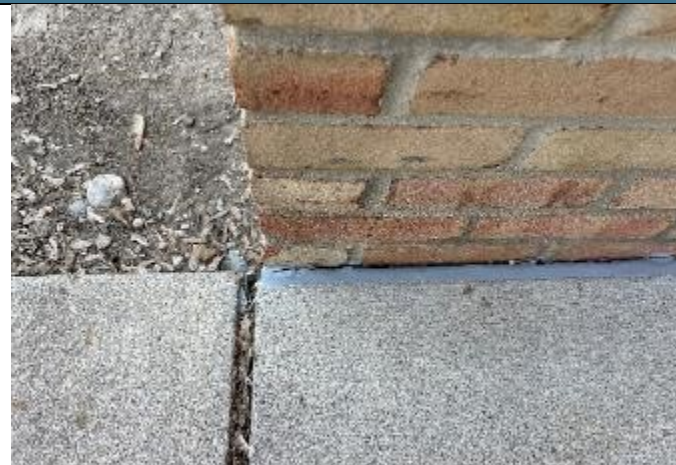
Photograph #78

HA-78: Exterior Dark Grey Cement Caulk

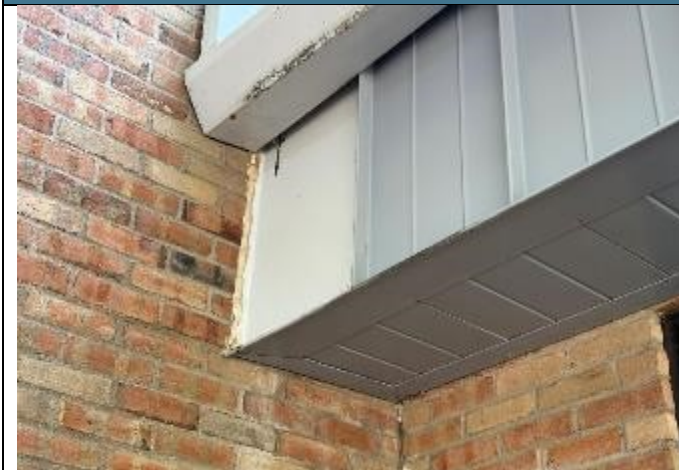
Photograph #79

HA-79: Exterior White Building Caulk

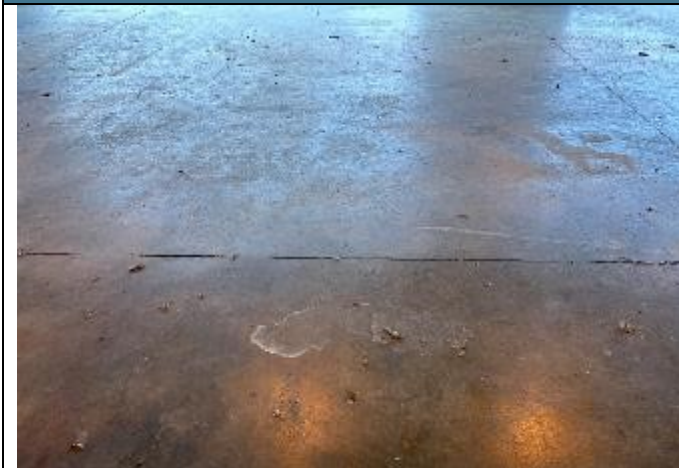
Photograph #80

HA-80: Outbuilding - Poured Concrete Floor

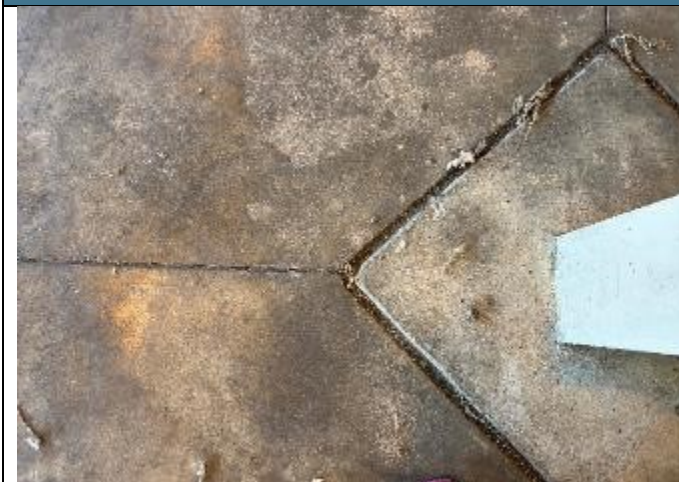
Photograph #81

HA-81: Outbuilding - Concrete Floor Expansion Joint

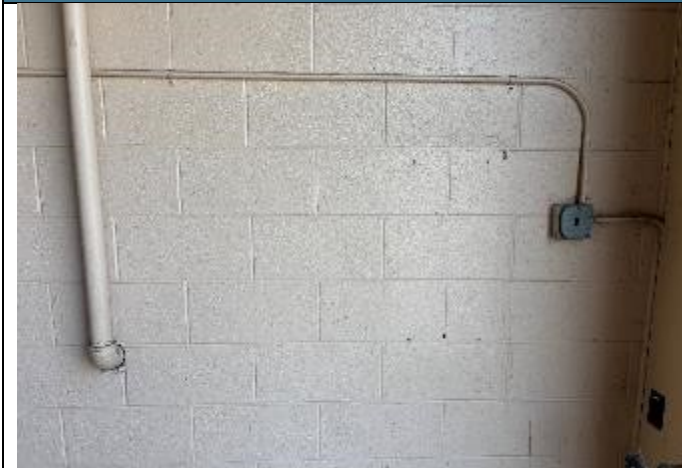
Photograph #82

HA-82: Outbuilding - CMU Block Wall

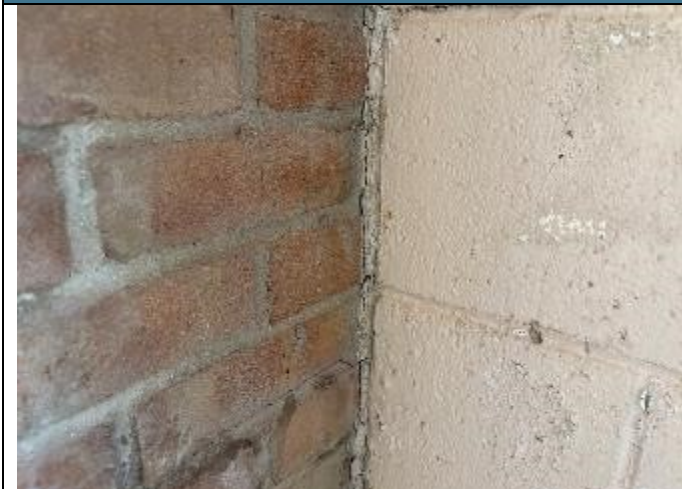
Photograph #83

HA-83: Outbuilding - CMU Block Wall
Expansion Joint

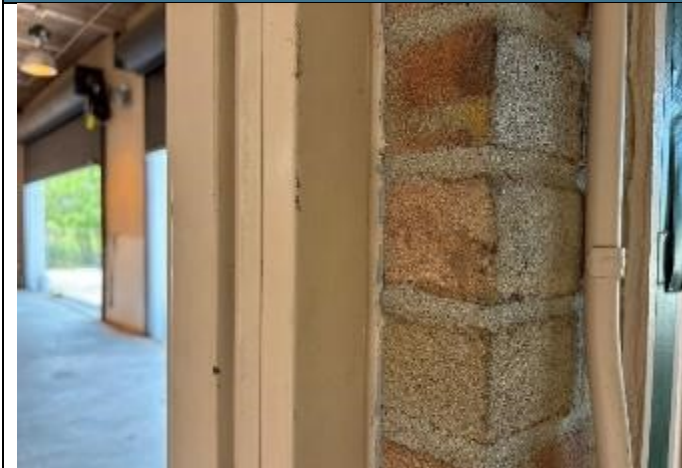
Photograph #85

Homogenous Material Description
HA-85: Outbuilding - Interior Grey Door Caulk
Asbestos Present (Yes/No/Assumed)
No
Total Quantity Present
130 LF
Additional Notes

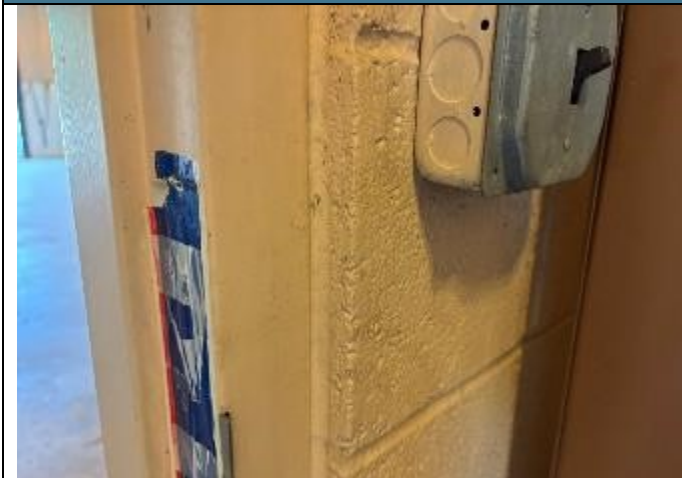
Photograph #86

Homogenous Material Description
HA-86: Outbuilding - White Multi-layer Building Caulk
Asbestos Present (Yes/No/Assumed)
No
Total Quantity Present
60 LF
Additional Notes

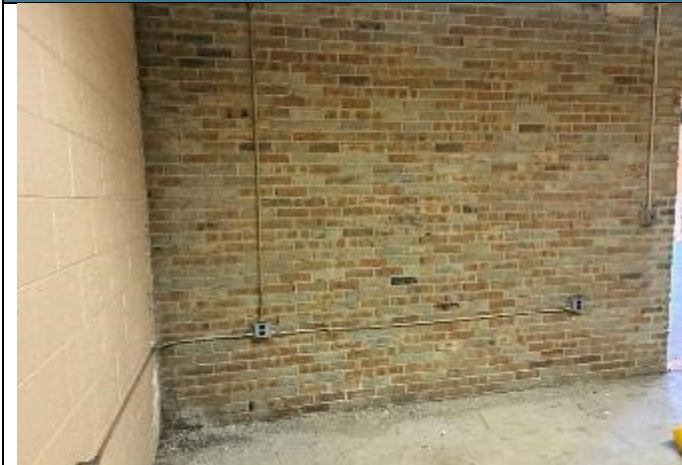
Photograph #87

Homogenous Material Description
HA-87: Outbuilding - Brick and Mortar
Asbestos Present (Yes/No/Assumed)
No
Total Quantity Present
2,320 SF
Additional Notes

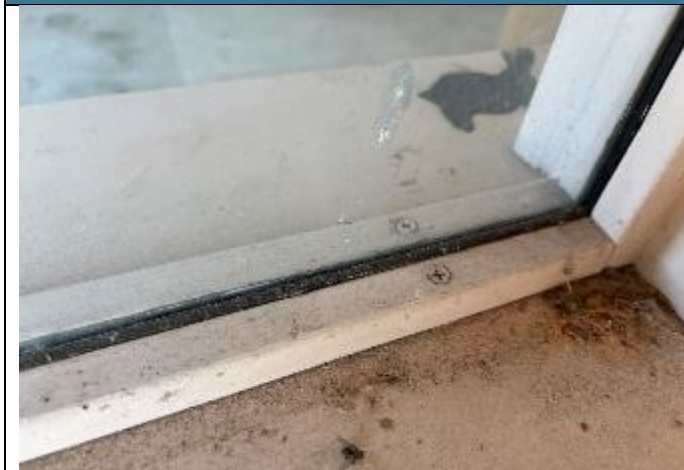
Photograph #88

Homogenous Material Description

HA-88: Outbuilding - Black Interior Window Caulk

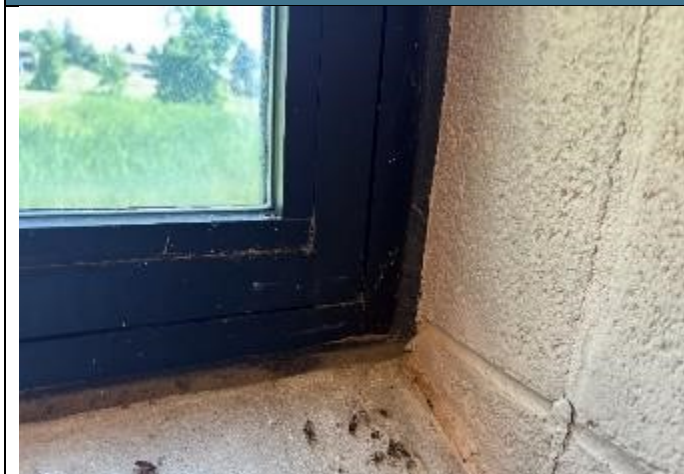
Photograph #89

Homogenous Material Description

HA-89: Outbuilding - Interior Black Window Caulk

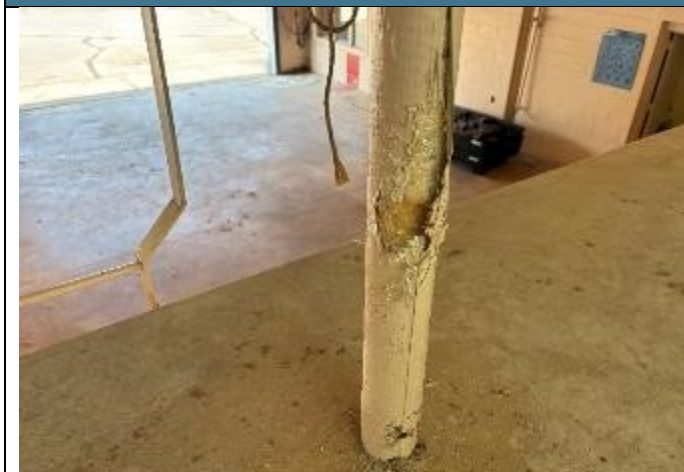
Photograph #90

Homogenous Material Description

HA-90: Outbuilding - Fiberglass Straight Pipe Insulation

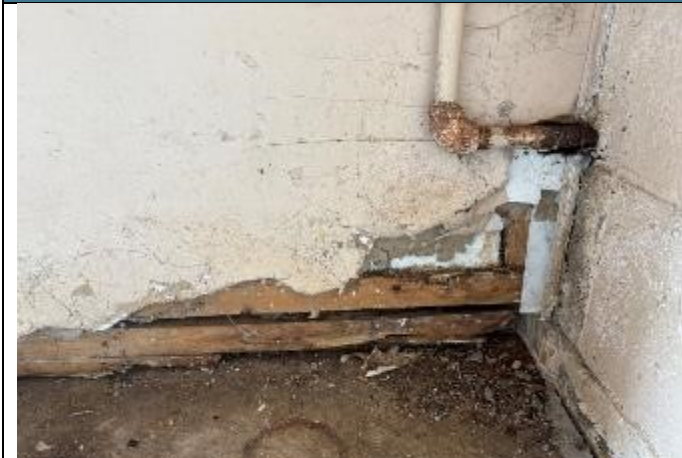
Photograph #91

Homogenous Material Description

HA-91: Outbuilding - Wallboard System

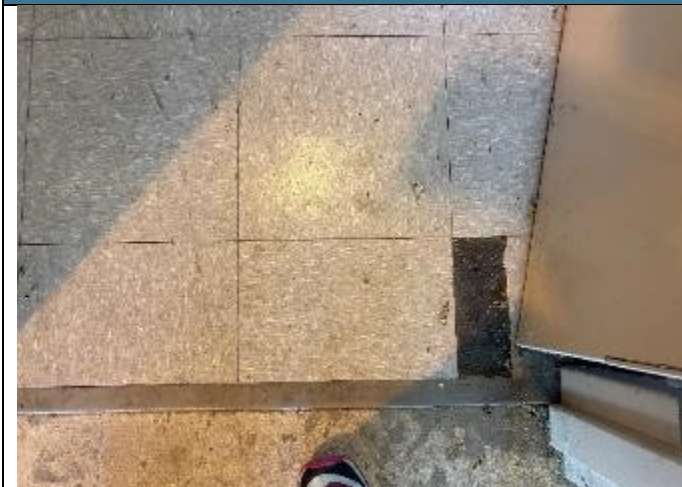
Photograph #92

Homogenous Material Description

HA-92: Outbuilding - 12" x 12" Blue/Grey
Mottled Floor Tile and Mastic

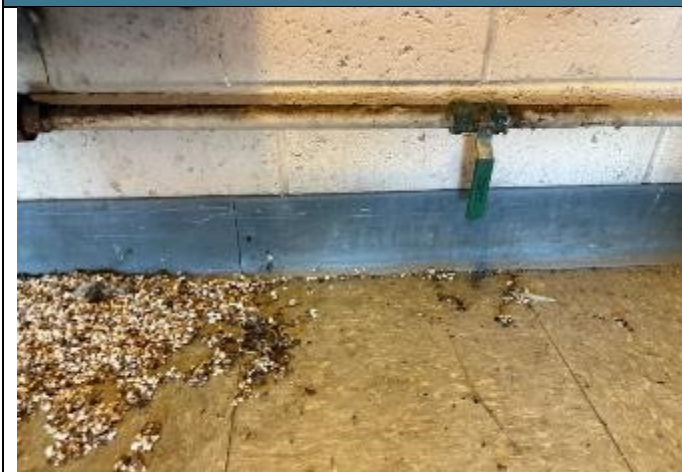
Photograph #93

Homogenous Material Description

HA-93: Outbuilding - 4" Blue Cove Base and
Adhesive

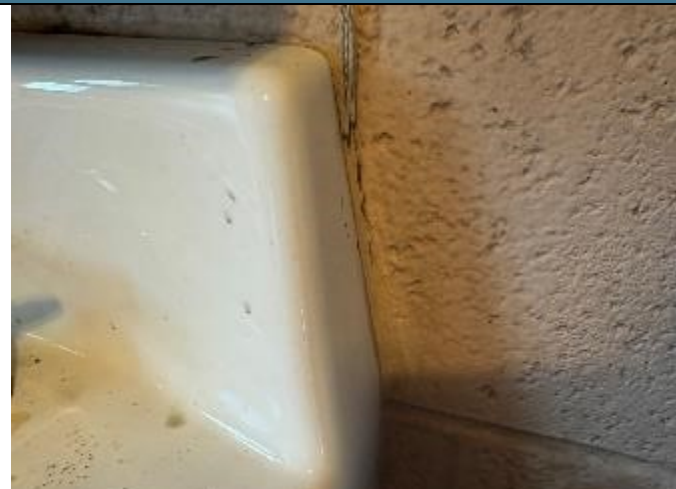
Photograph #95

Homogenous Material Description

HA-95: Outbuilding - Interior White Plumbing Caulk

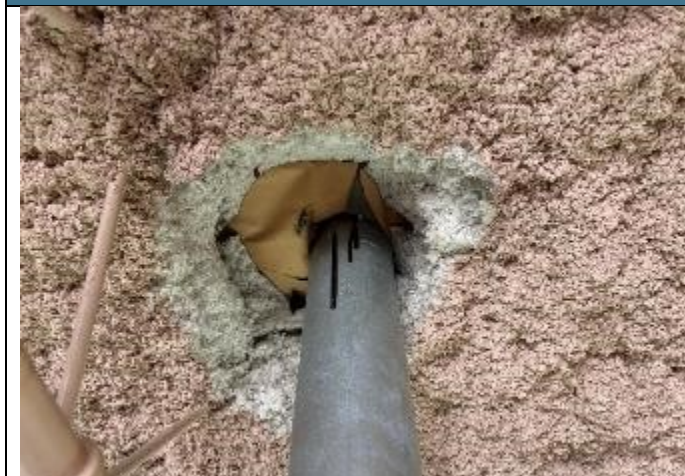
Photograph #98

Homogenous Material Description
HA-98: Outbuilding - Brown Paper Roof Drain Insulation
Asbestos Present (Yes/No/Assumed)
No
Total Quantity Present
5 SF
Additional Notes

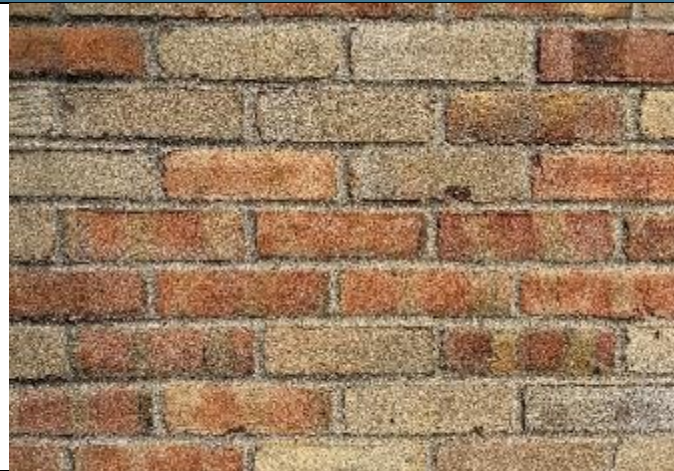
Photograph #100

Homogenous Material Description
HA-100: Outbuilding - Exterior Brick and Mortar
Asbestos Present (Yes/No/Assumed)
No
Total Quantity Present
10,000 SF
Additional Notes

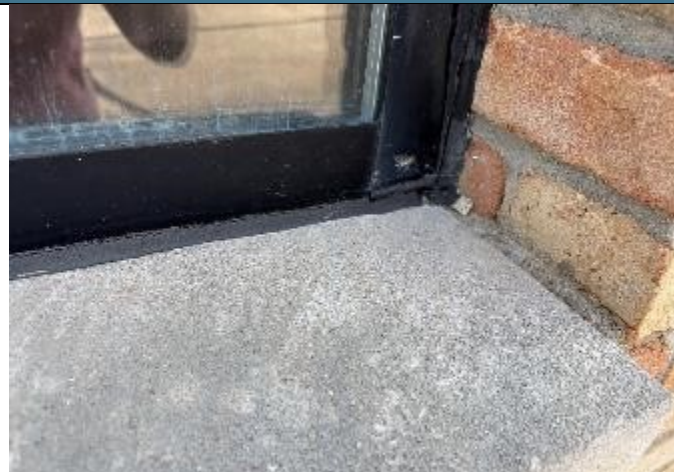
Photograph #101

Homogenous Material Description
HA-101: Outbuilding - Exterior Black Window Caulk
Asbestos Present (Yes/No/Assumed)
No
Total Quantity Present
15 LF
Additional Notes
